October 1, 2024

3309

**Reconnaissance Observations and Recommendations Report  
3<sup>rd</sup> Avenue and Copper Ridge Landslide Assessments  
Ketchikan, AK**

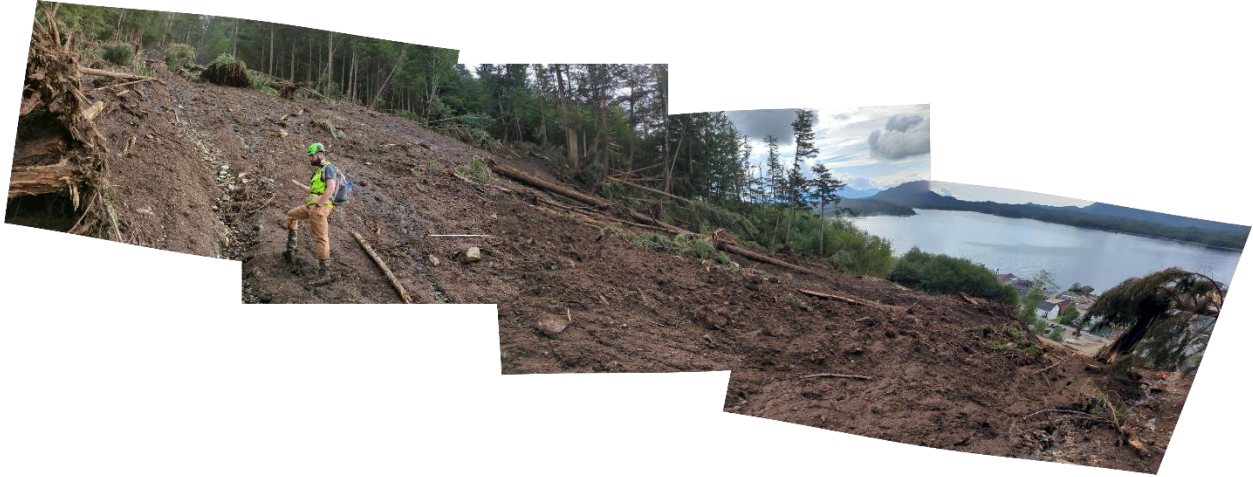
A: 3rd Avenue Landslide, Point 1, slide debris.

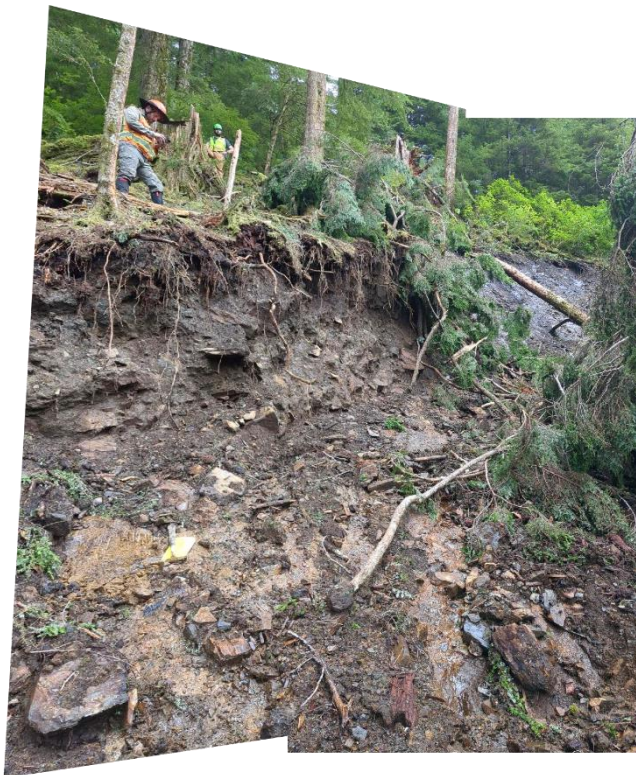
B: 3rd Avenue Landslide, Point 33, colluvium exposures.

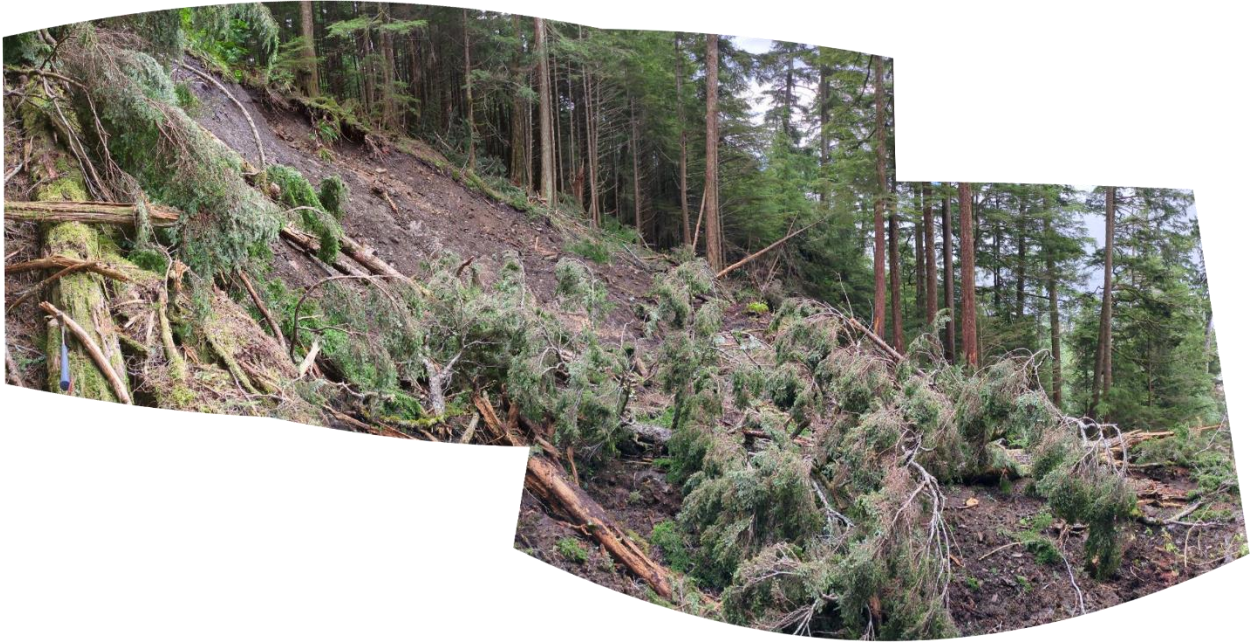
A: 3rd Avenue Landslide, Point 37, colluvium deposits.

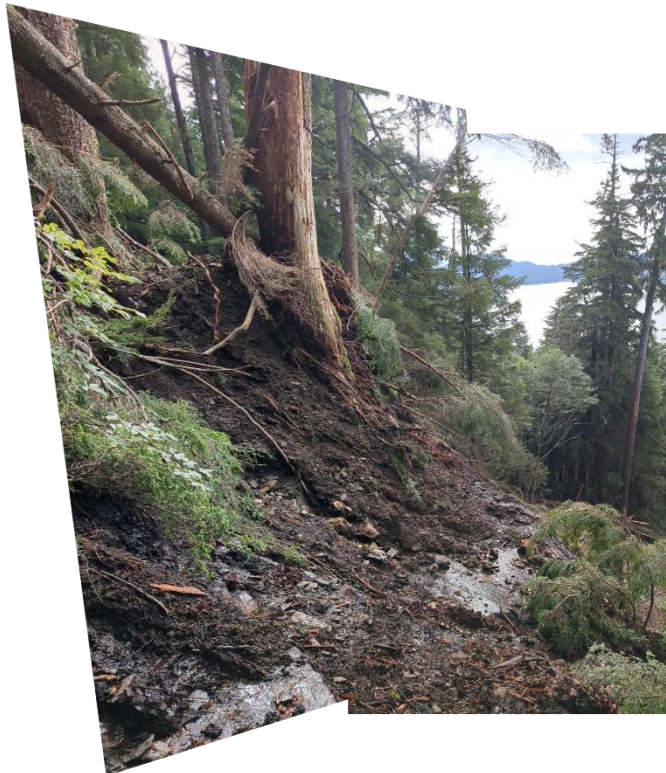
B: 3rd Avenue Landslide, Point 30, colluvium deposits under an isolated tree within slide mass.

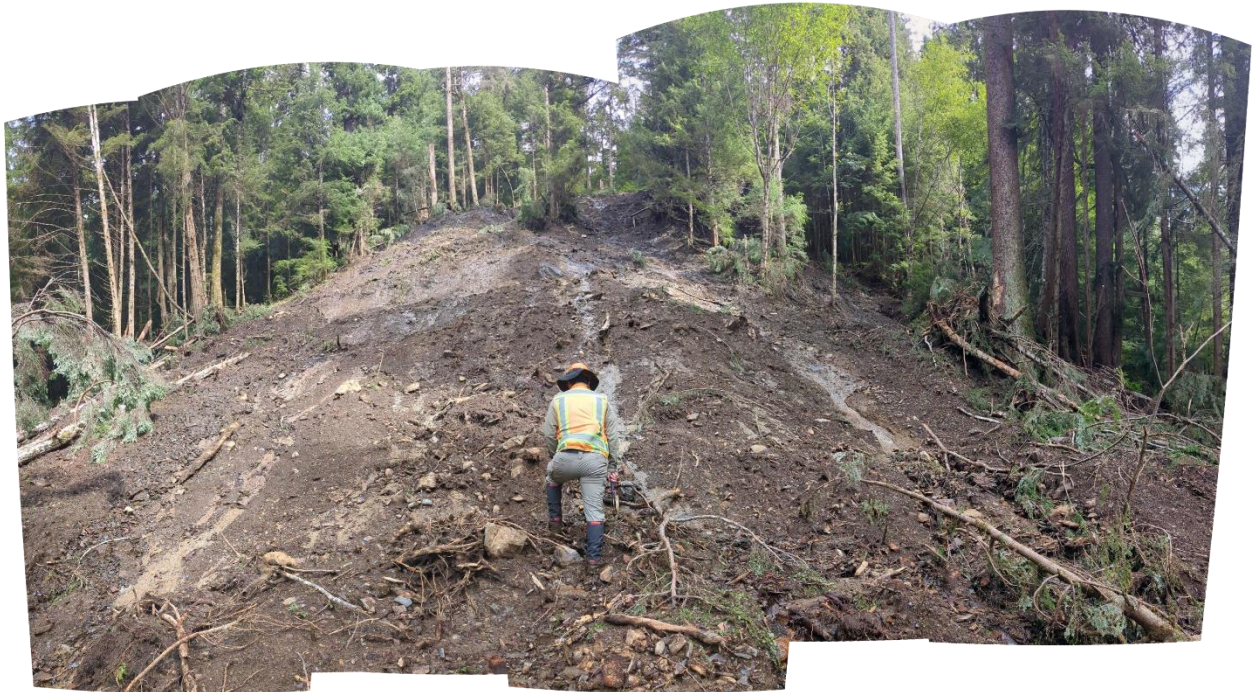
A: 3rd Avenue Landslide, Point 35, glacial till exposure in recently developed drainage channel.

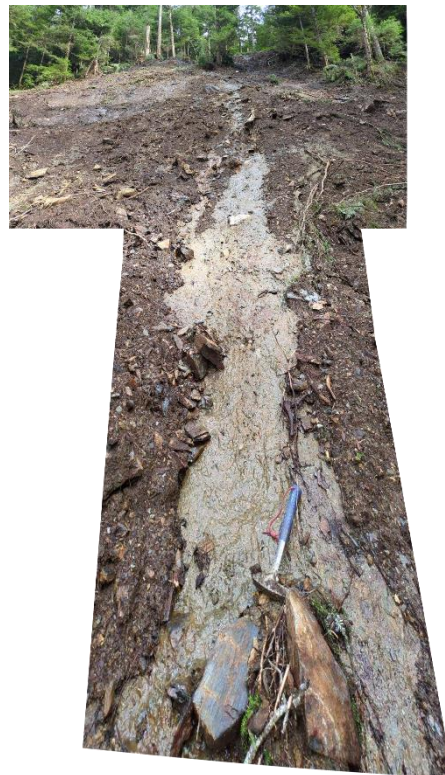
B: 3rd Avenue Landslide, Point 10, glacial till exposure in recently developed drainage channel.

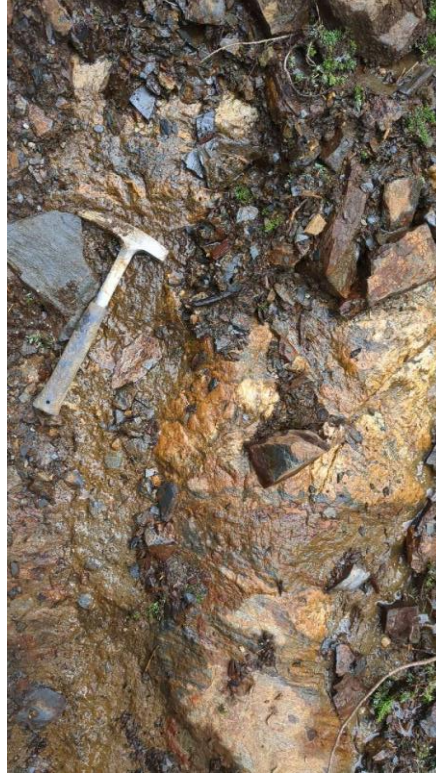
A: 3rd Avenue Landslide, Point 26, glacial till exposure.

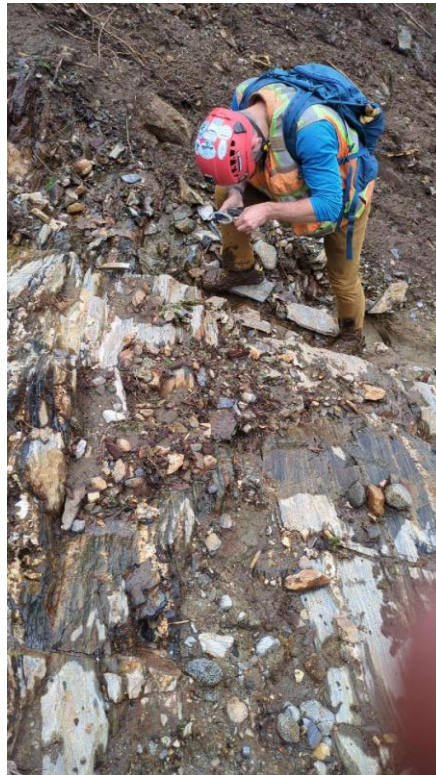
B: 3rd Avenue Landslide, Point 5, phyllite exposure.

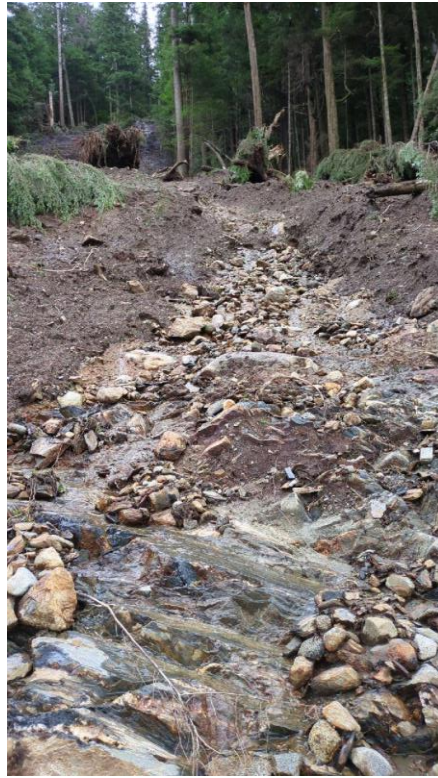
A: 3rd Avenue Landslide, Point 5, phyllite exposure in recently developed drainage channel.

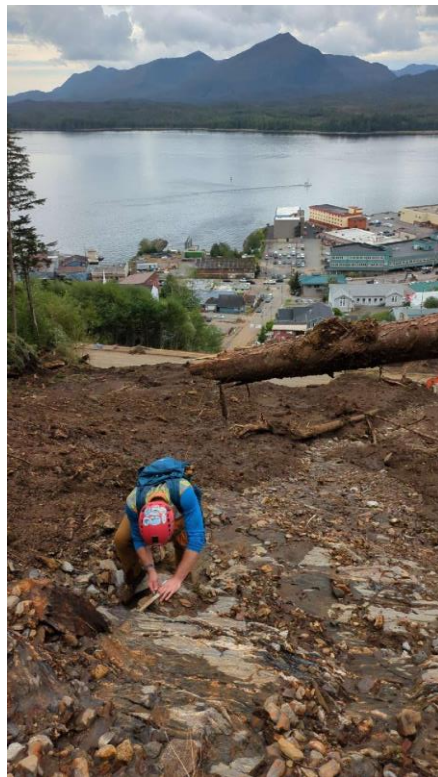
B: 3rd Avenue Landslide, Point 5, phyllite exposure in recently developed drainage channel.

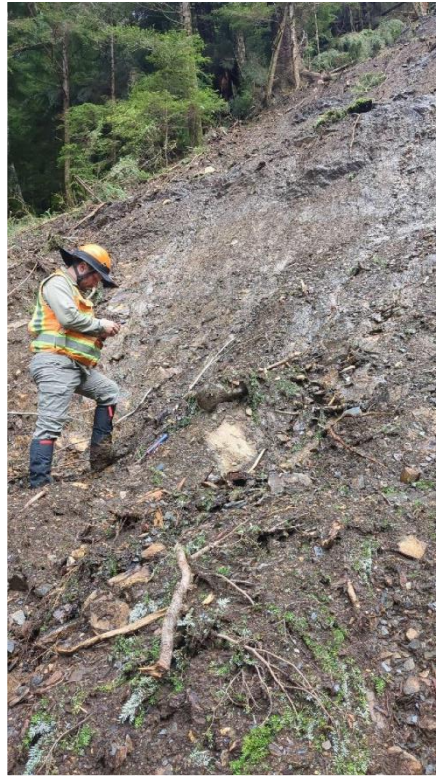
A: 3rd Avenue Landslide, Point 5, phyllite exposure below headscarp with unfavorable jointing.

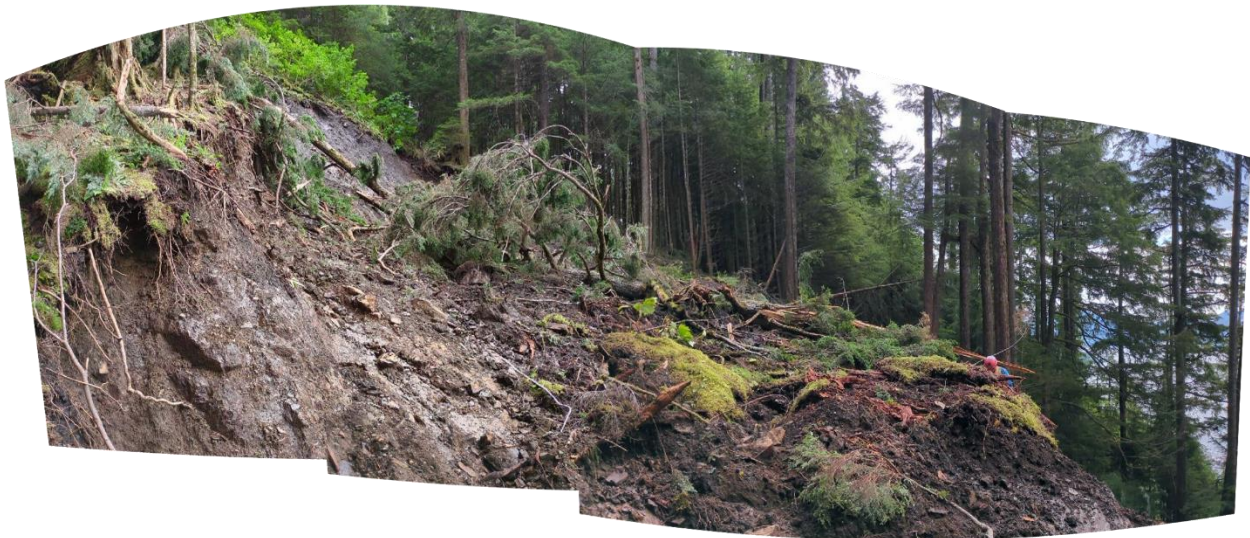
B: 3rd Avenue Landslide, Point 15, west side of headscarp looking southeast.

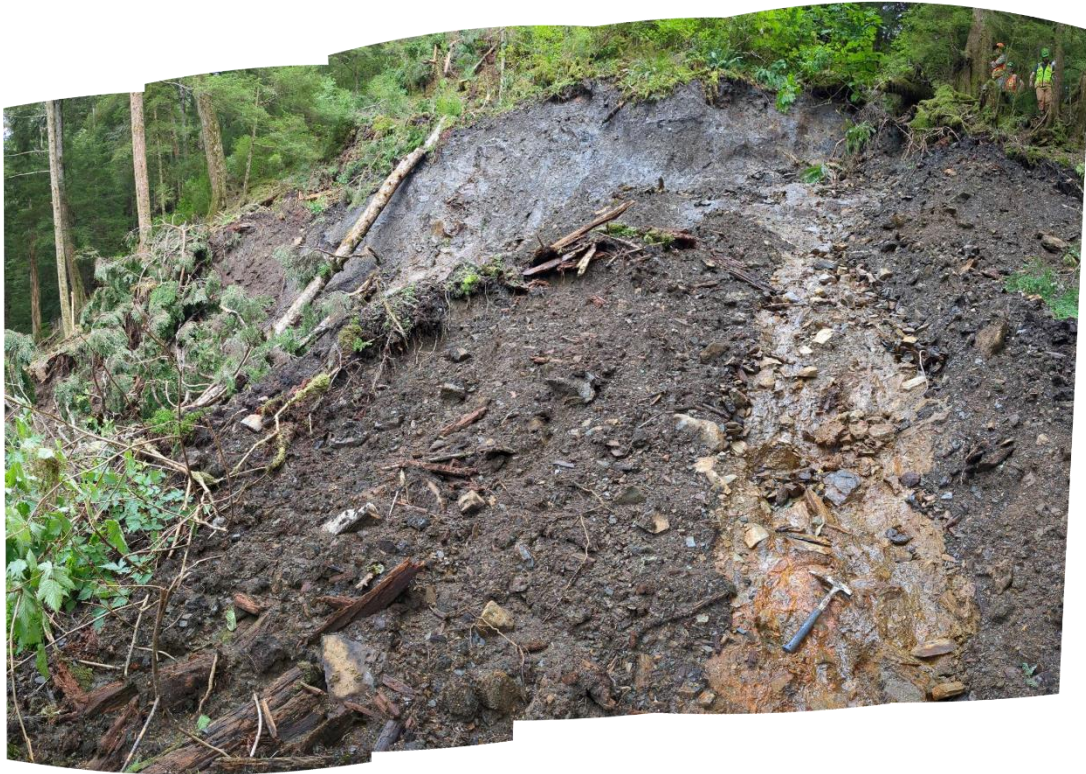
A: 3rd Avenue Landslide, Point 15, middle portion of headscarp looking upslope to northeast.

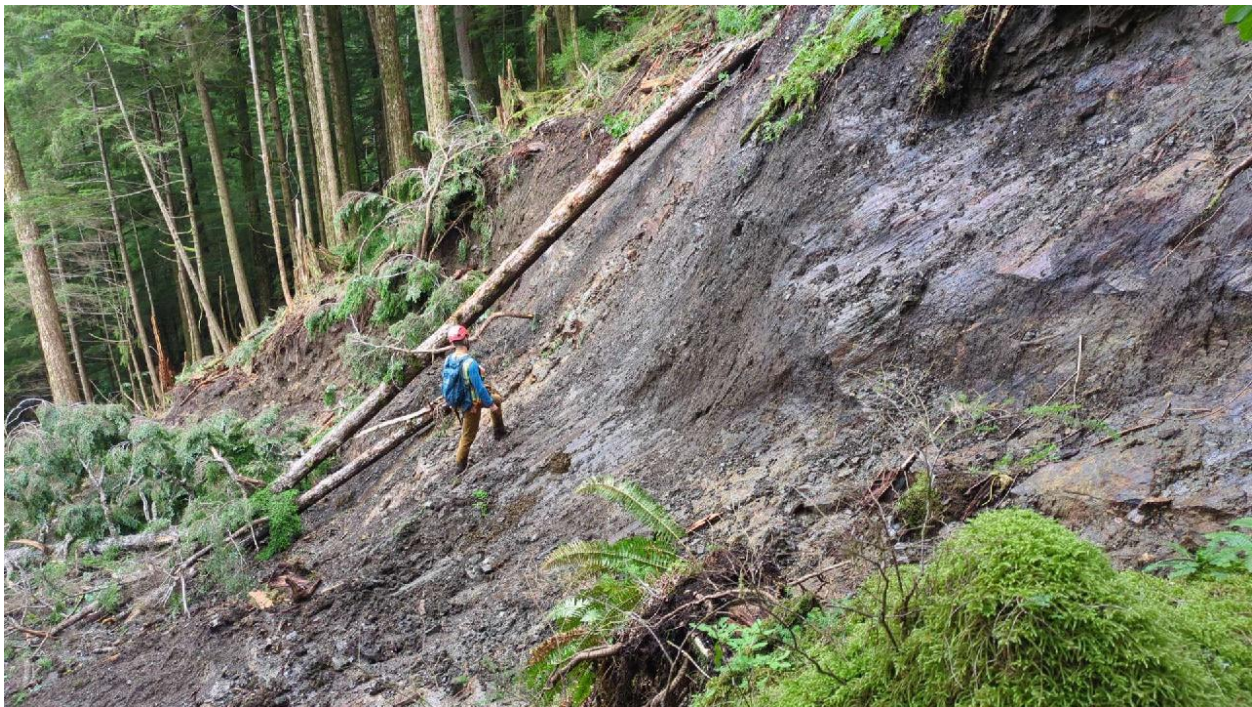
B: 3rd Avenue Landslide, Point 15, east side of headscarp looking north.

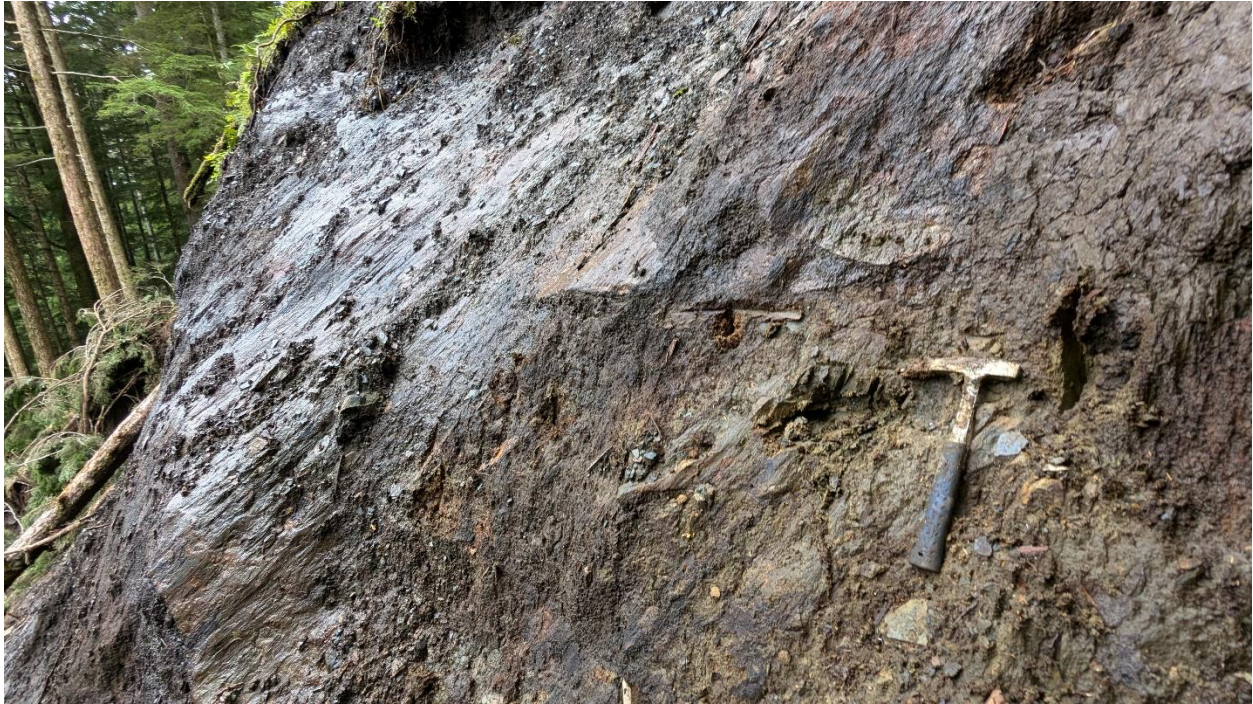
A: 3rd Avenue Landslide, Point 46, exposure of decomposed phyllite with slickensides.

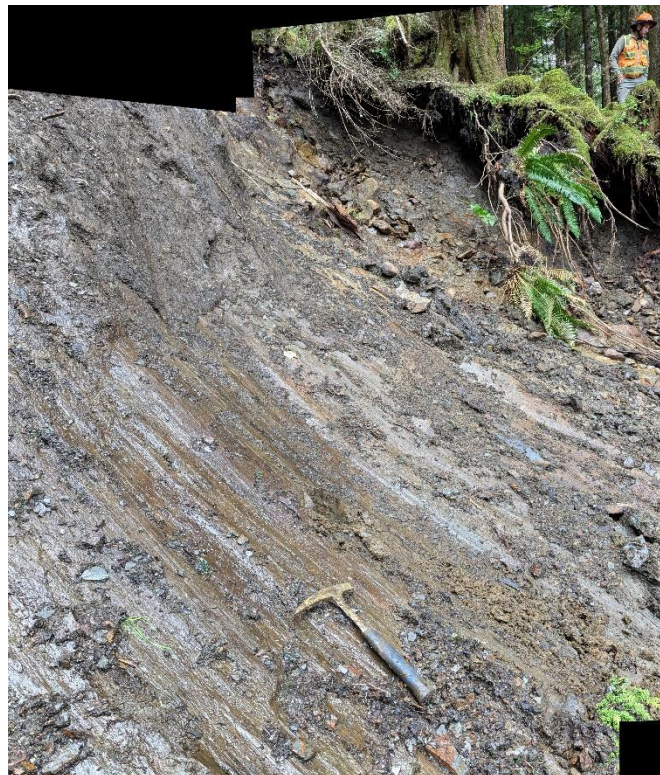
B: 3rd Avenue Landslide, Point 47, exposure of decomposed phyllite with slickensides.

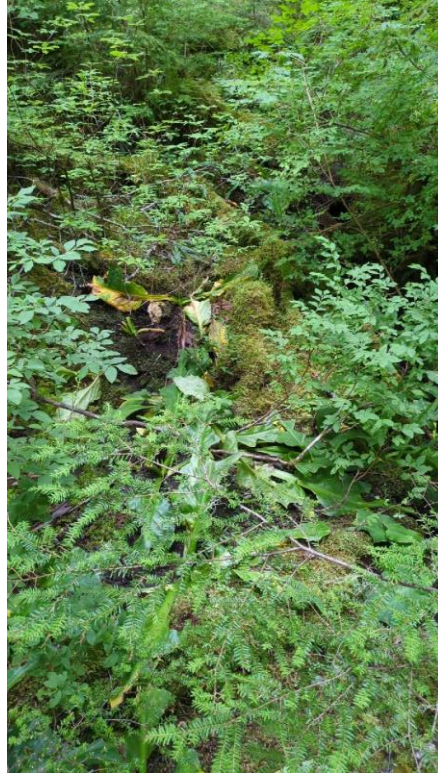
water was observed above the lineation feature, wetland vegetation (i.e., skunk cabbage, muskeg) was observed indicating an upslope source of water (Photo Exhibit 9).

A: 3rd Avenue Landslide, Point 43, wet area upslope of landslide headscarp. Note skunk cabbage growth.

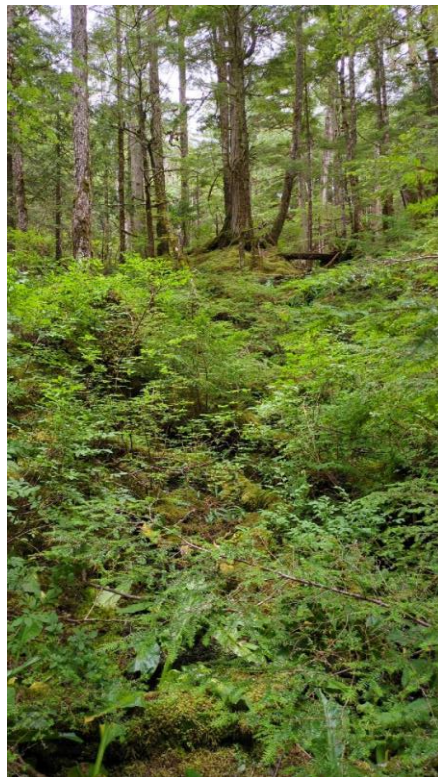
B: 3rd Avenue Landslide, Point 43, wet area upslope of landslide headscarp.

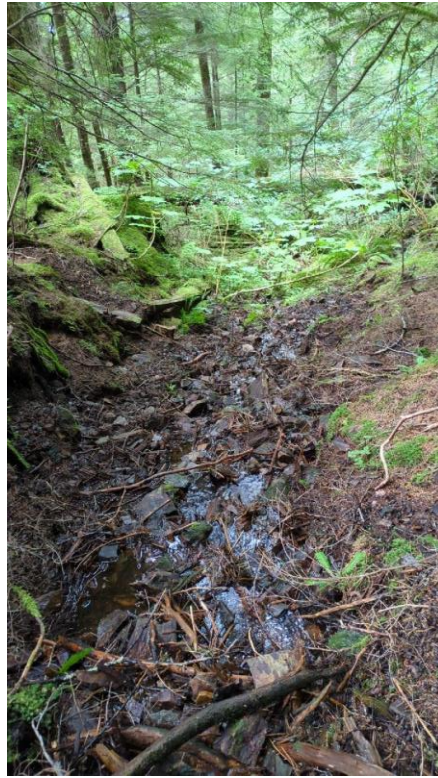
A: 3rd Avenue Landslide, Point 13, western drainage adjacent to landslide looking down slope (~south).

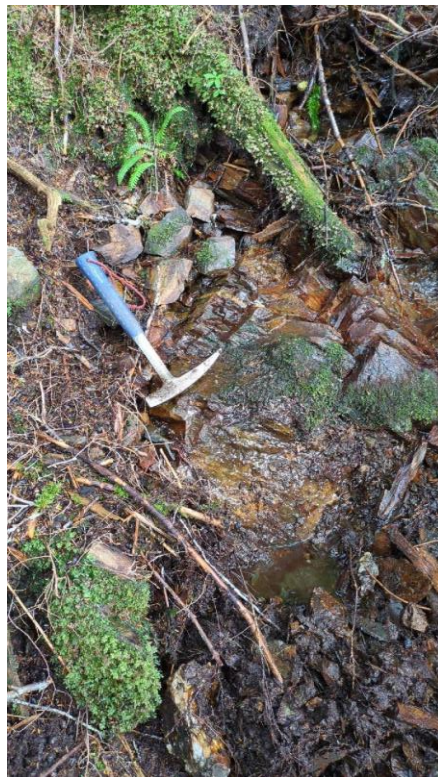
B: 3rd Avenue Landslide, Point 13, western drainage adjacent to landslide showing water flowing on phyllite exposure.

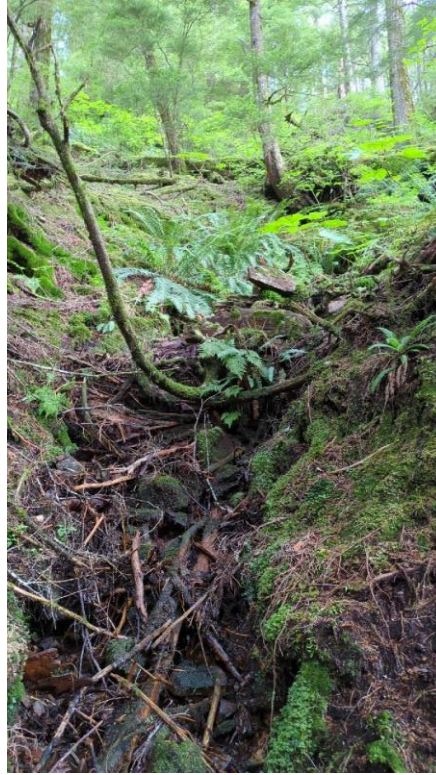
A: 3rd Avenue Landslide, Point 13, western drainage adjacent to landslide looking upslope (~north).

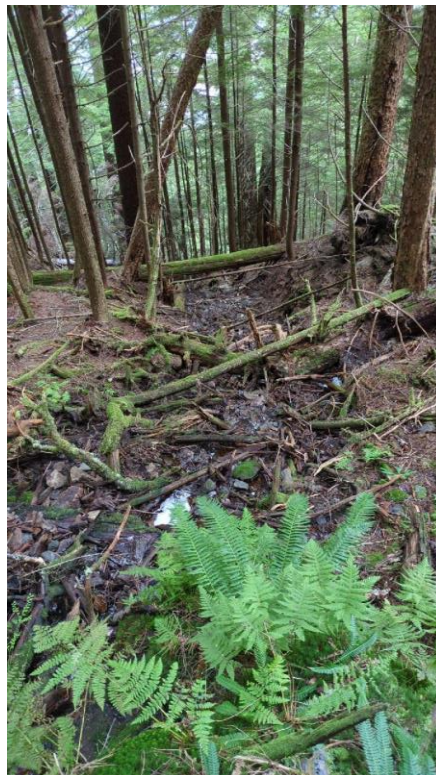
B: 3rd Avenue Landslide, Point 42, eastern drainage adjacent to landslide looking downslope (~south).

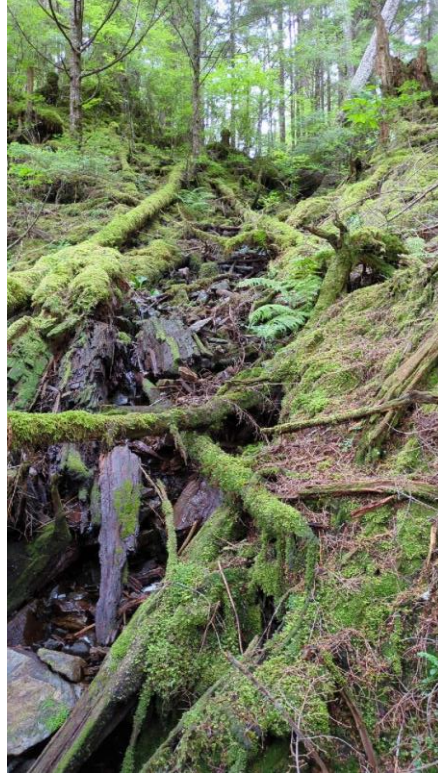
A: 3rd Avenue Landslide, Point 42, eastern drainage adjacent to landslide looking upslope (~north).

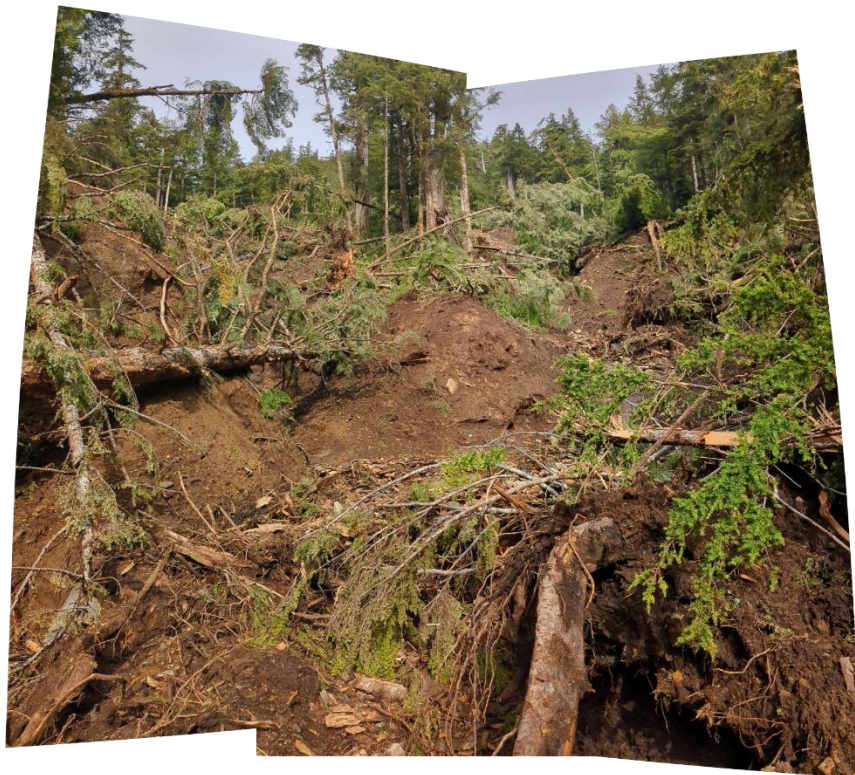
B: Copper Ridge Landslide, Point 1028, Upper Zone, colluvium deposits, looking northwest.

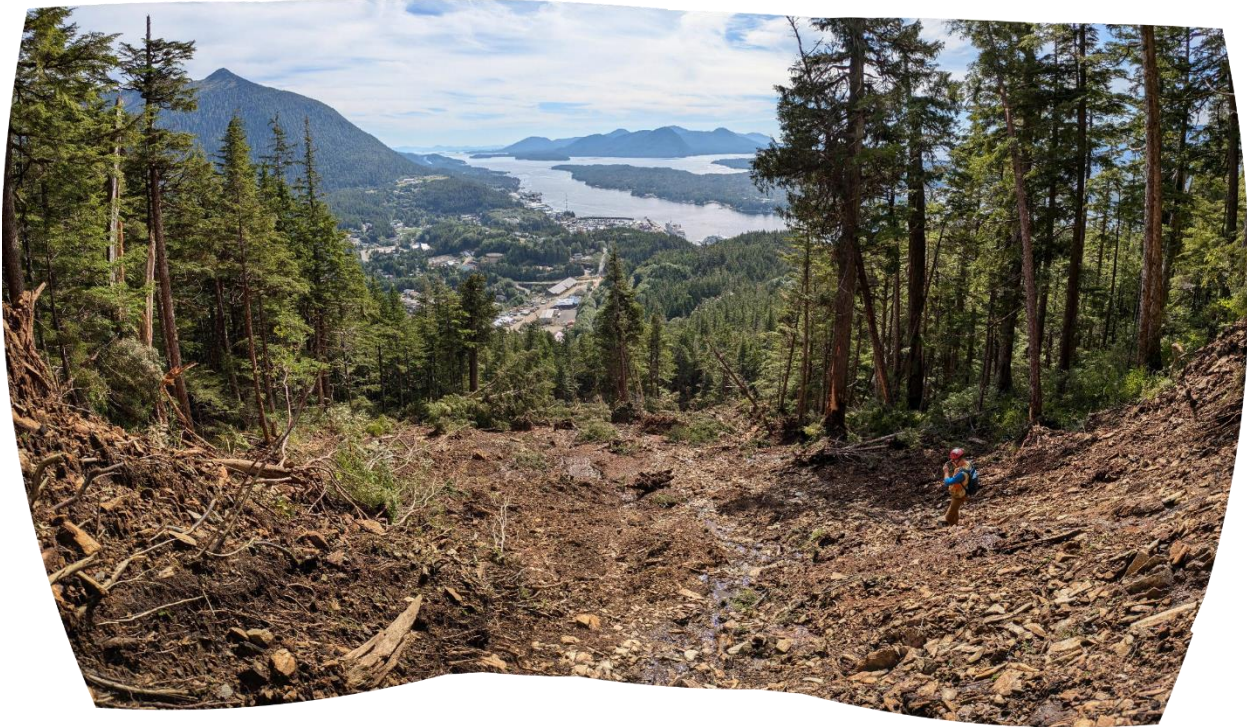
A: Copper Ridge Landslide, Point 1068, Upper Zone, thin colluvial deposits, looking southeast.

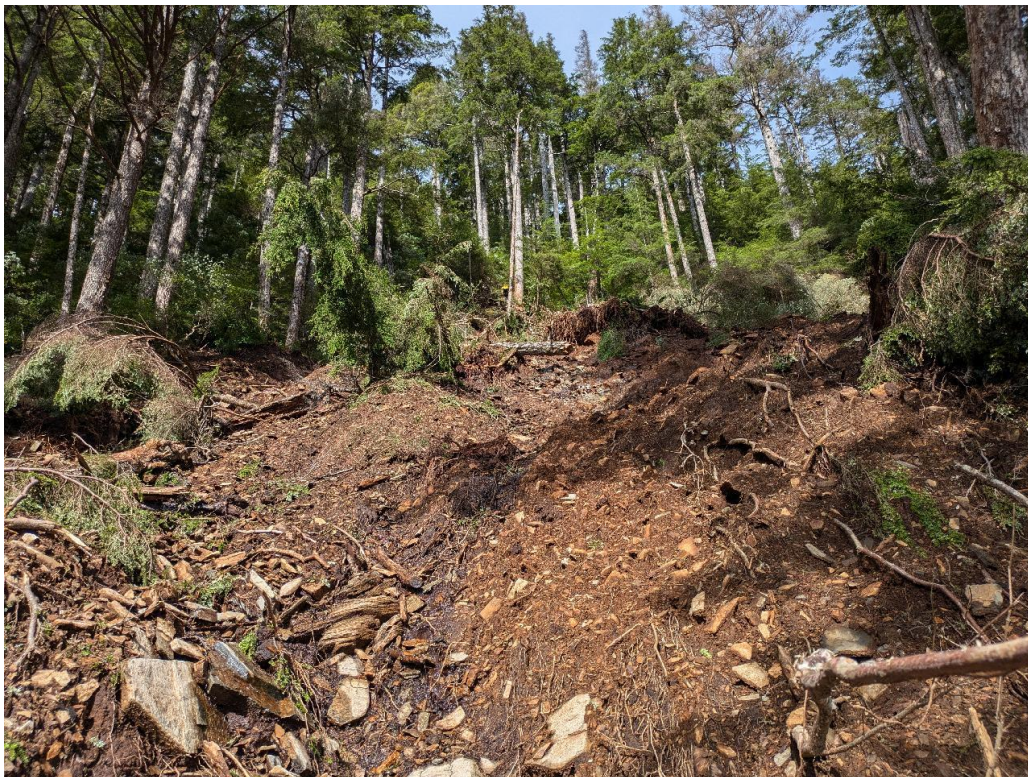
B: Copper Ridge Landslide, Point 1068, Upper Zone, thin colluvial deposits, looking northwest.

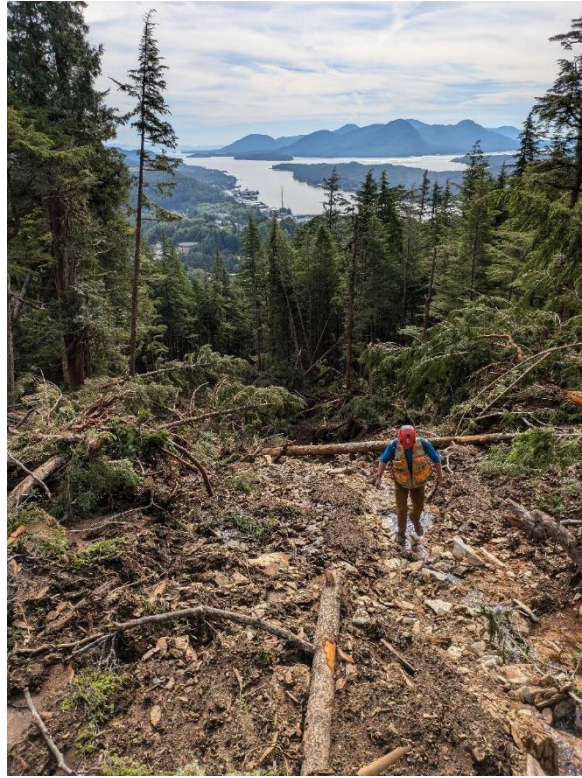
A: Copper Ridge Landslide, Point 1065, Upper Zone, bedrock exposures in newly formed stream channels looking southeast.

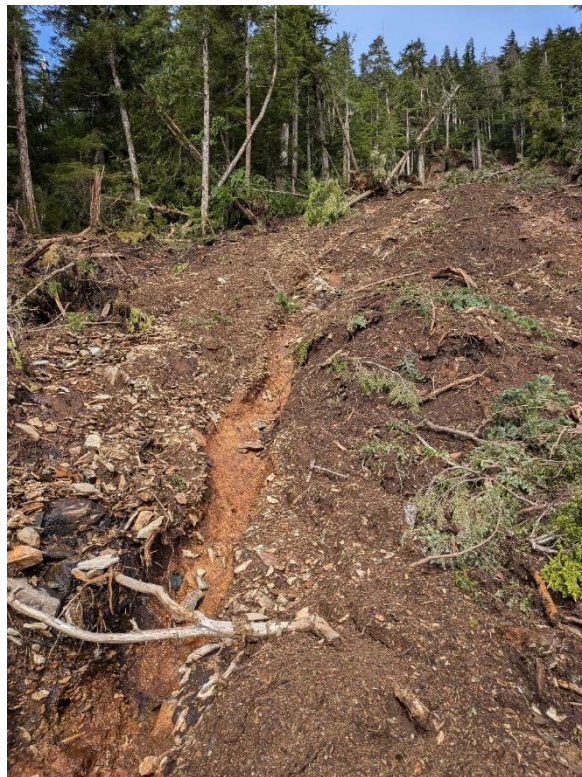
B: Copper Ridge Landslide, Point 1065, Upper Zone, bedrock exposures in newly formed stream channels, looking northwest.

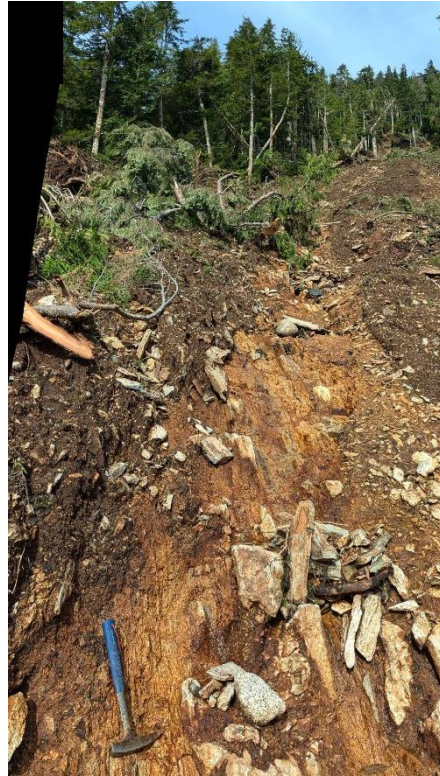
A: Copper Ridge Landslide, Point 1064, Upper Zone, schist outcropping in recently scoured stream channel.

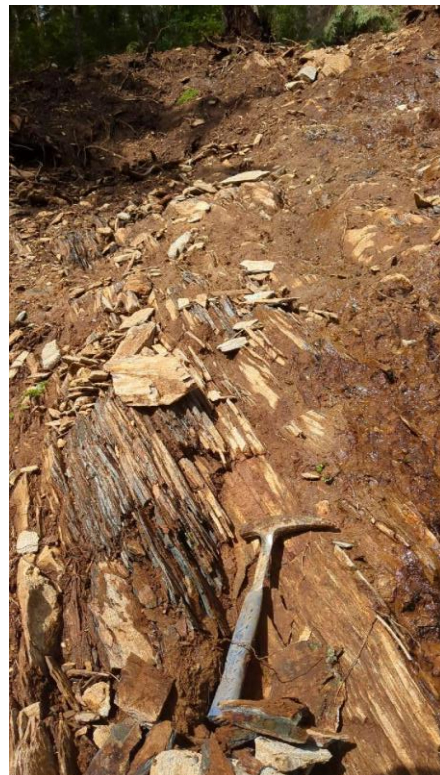
B: Copper Ridge Landslide, Point 1037, Upper Zone, phyllite bedrock exposure.

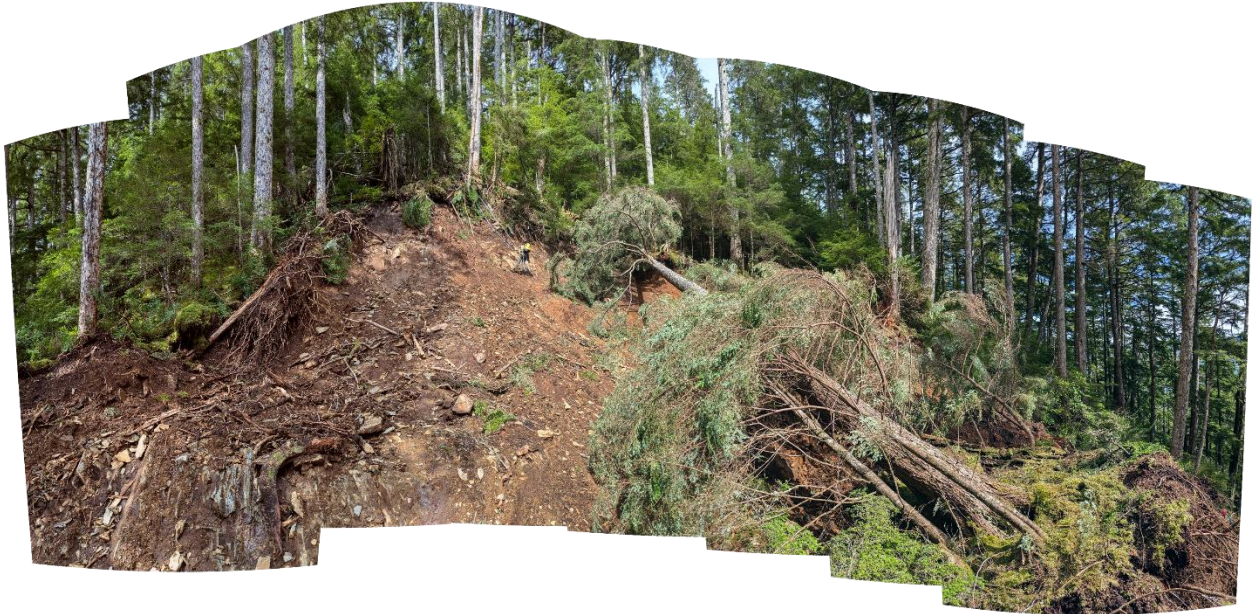
A: Copper Ridge Landslide, Point 1069, Upper Zone, headscarp conditions looking north.

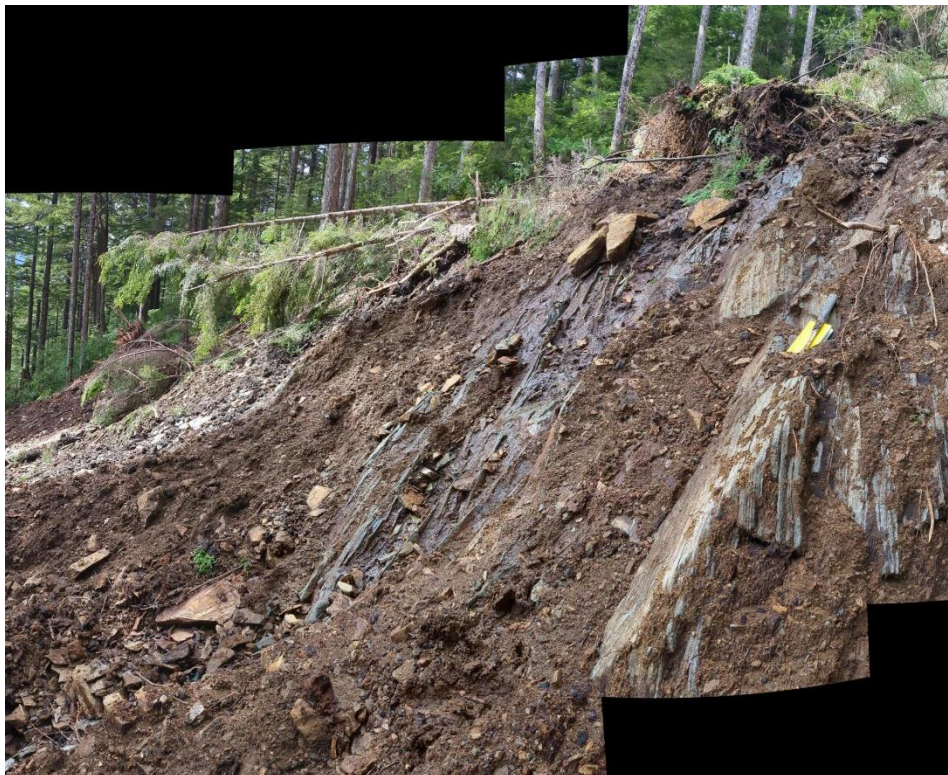
B: Copper Ridge Landslide, Point 1038, Upper Zone, headscarp conditions with phyllite bedrock exposures, looking northwest.

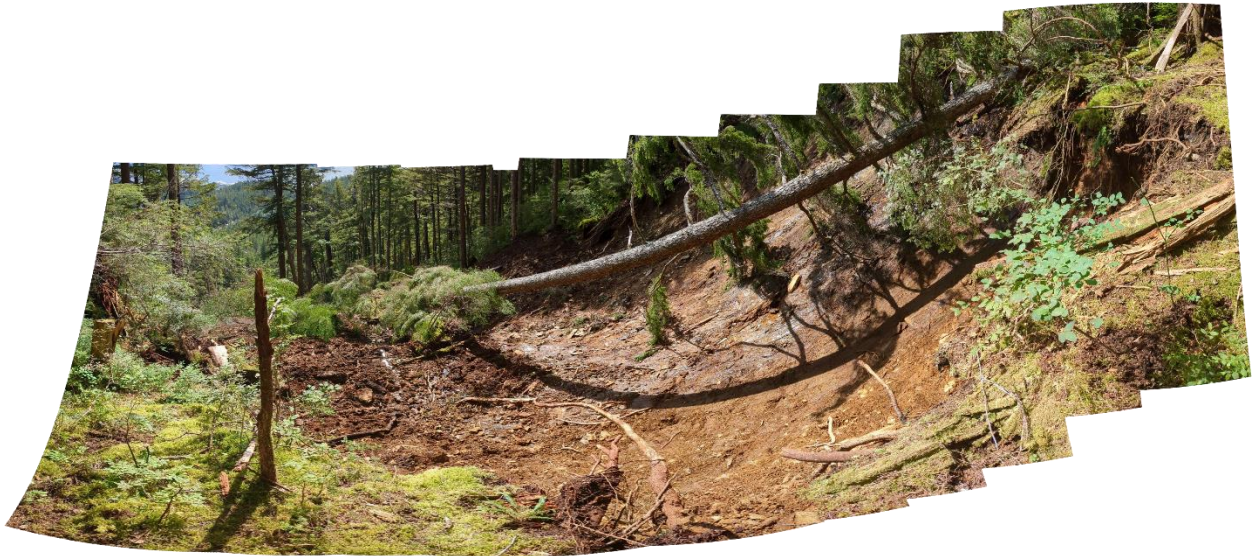
A: Copper Ridge Landslide, Point 1041, Upper Zone, headscarp conditions looking northwest.

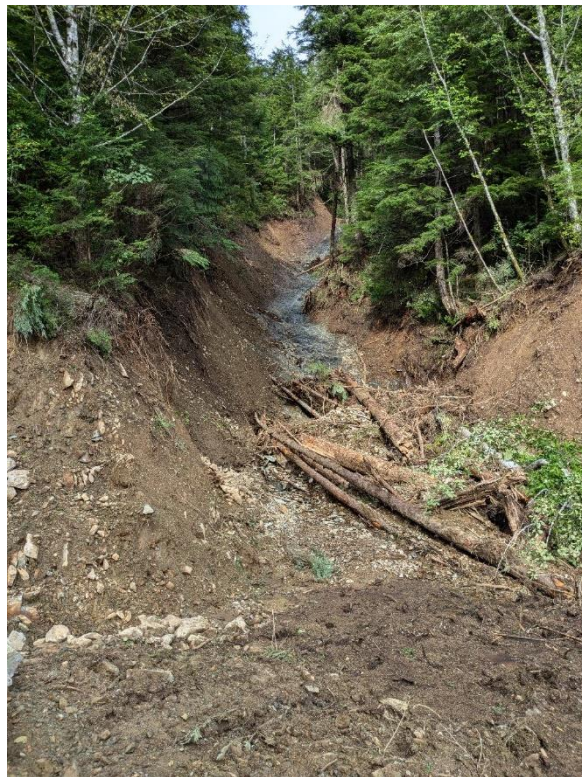
B: Copper Ridge Landslide, Point 1021, Middle Zone conditions with steep colluvial slopes.

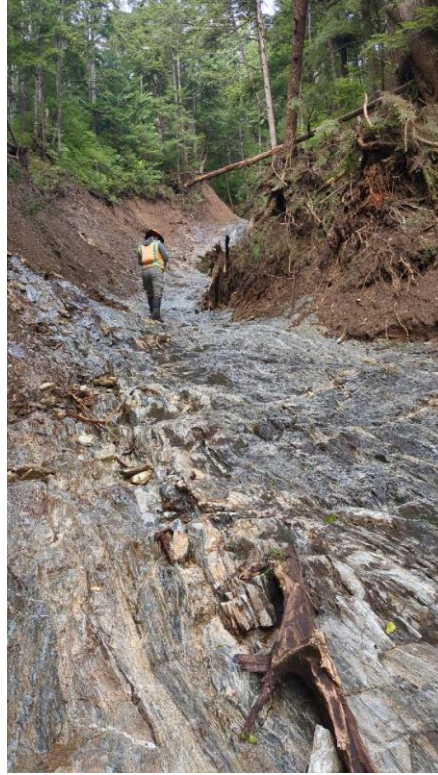
A: Copper Ridge Landslide, Point 1023, Middle Zone conditions with scoured bedrock exposures.

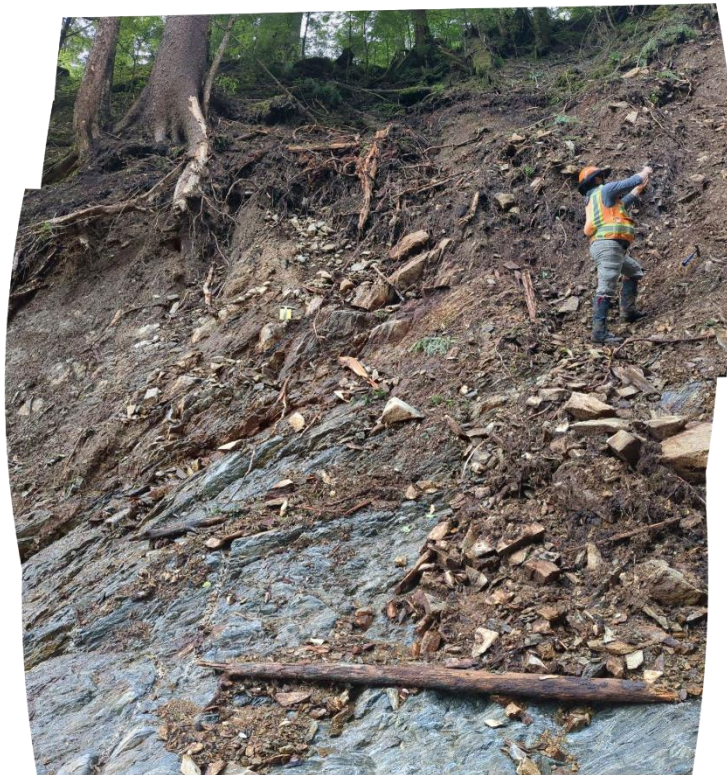
B: Copper Ridge Landslide, Point 1024, Middle Zone conditions with colluvium exposures.

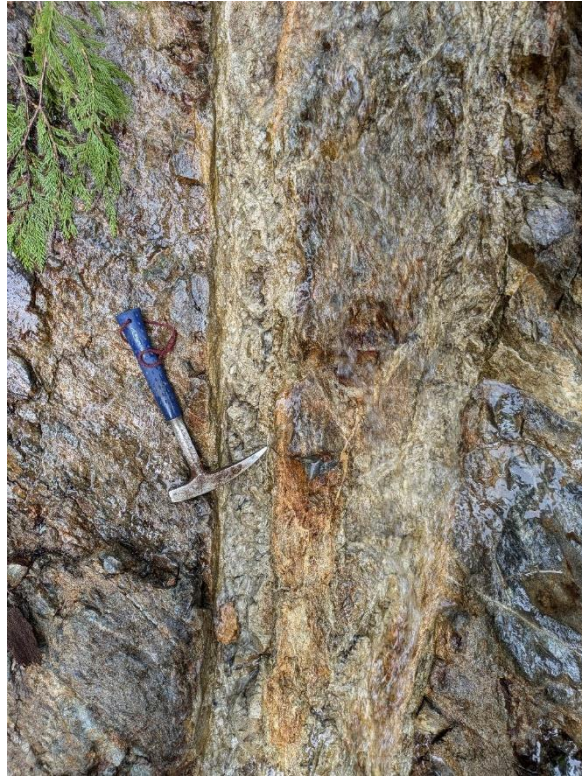
A: Copper Ridge Landslide, Point 1059, Middle Zone fault gouge in upper scoured stream channel.

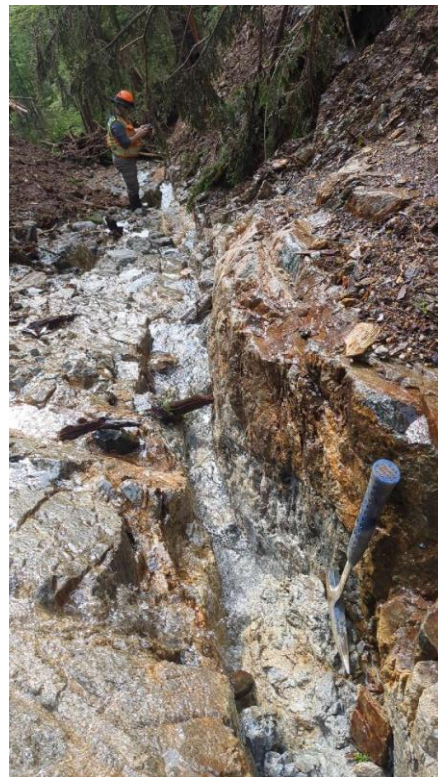
B: Copper Ridge Landslide, Point 1059, Middle Zone fault gouge in upper scoured stream channel looking southeast.

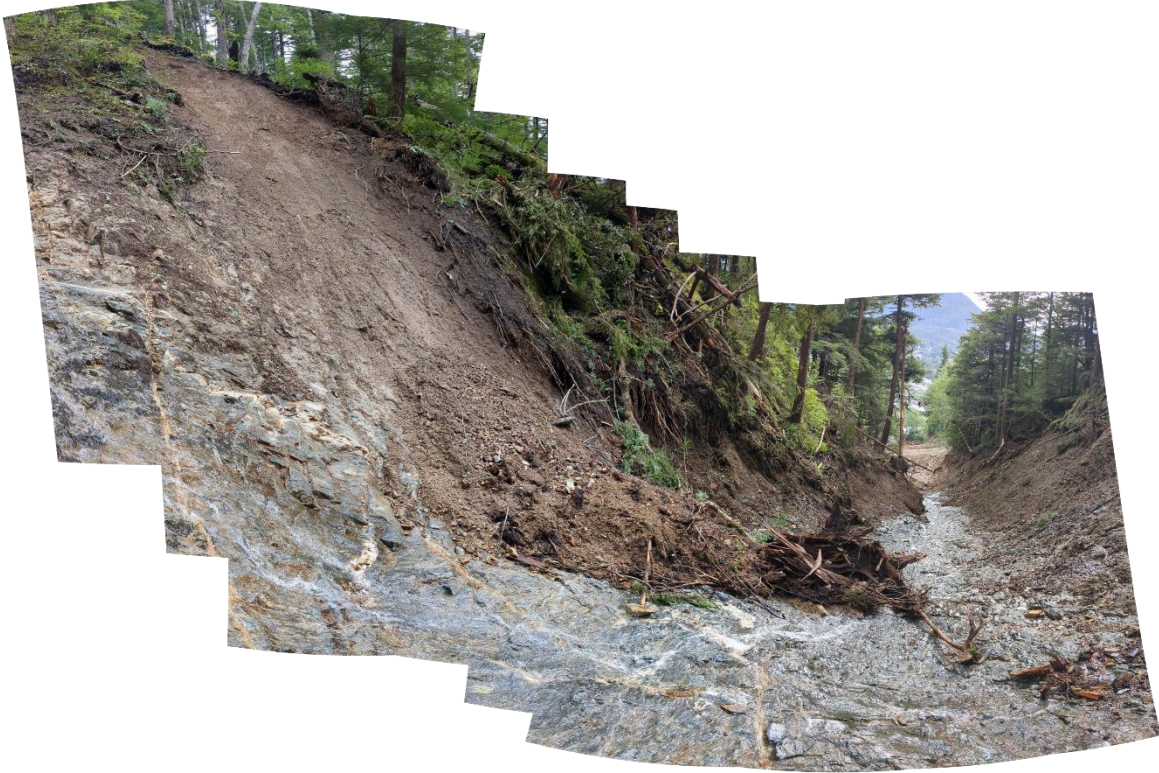
A: Copper Ridge Landslide, Point 1025, Middle Zone conditions with recent shallow failures.

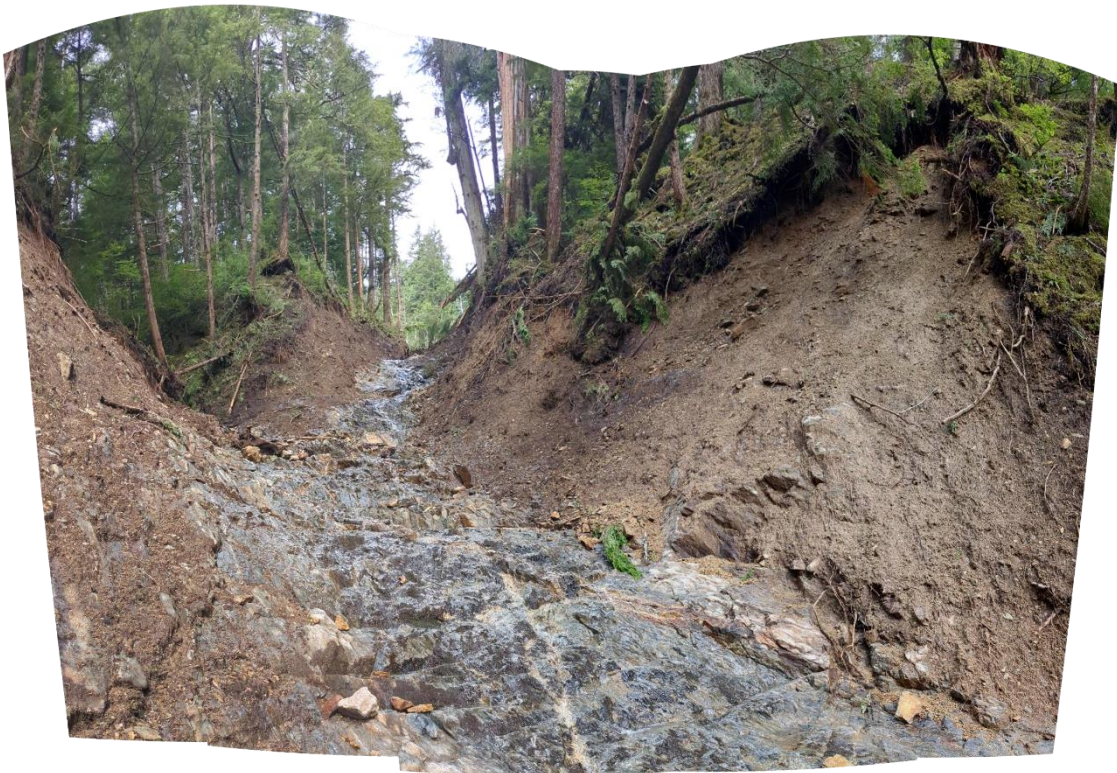
B: Copper Ridge Landslide, Point 1025, Middle Zone schist exposures surrounded by overhung topsoil exposures.

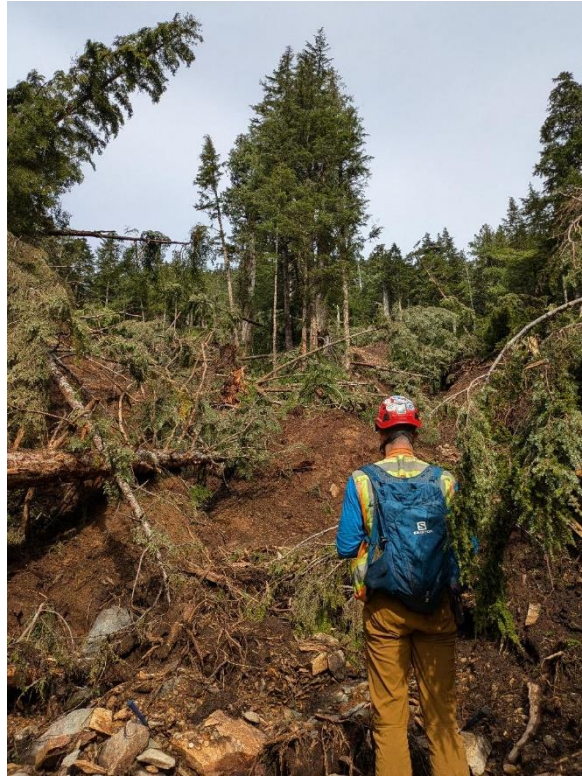
A: Copper Ridge Landslide, Point 1028, Upper and Middle Zone Transition, base of source area at topographic convergence, looking northwest.
