October 1, 2024

3309

**Reconnaissance Observations and Recommendations Report  
3<sup>rd</sup> Avenue and Copper Ridge Landslide Assessments  
Ketchikan, AK**

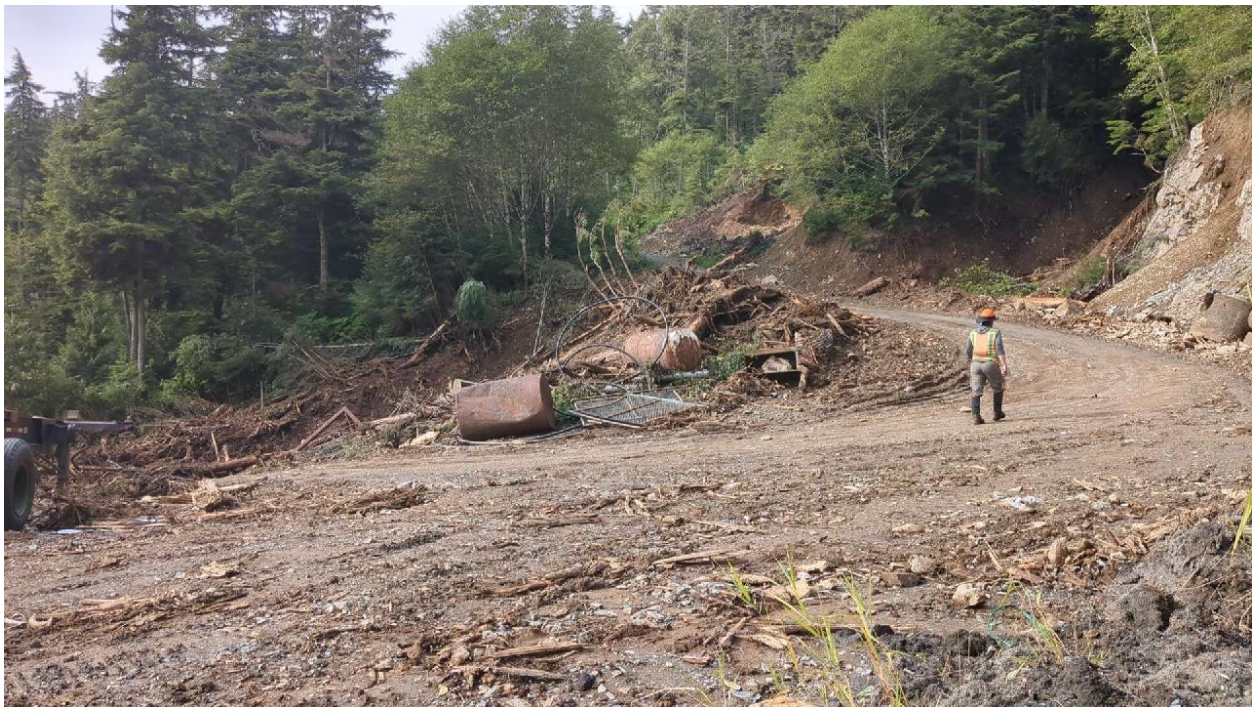
B: Copper Ridge Landslide, Point 1022, Lower Zone, debris accumulation at access driveway switchback.

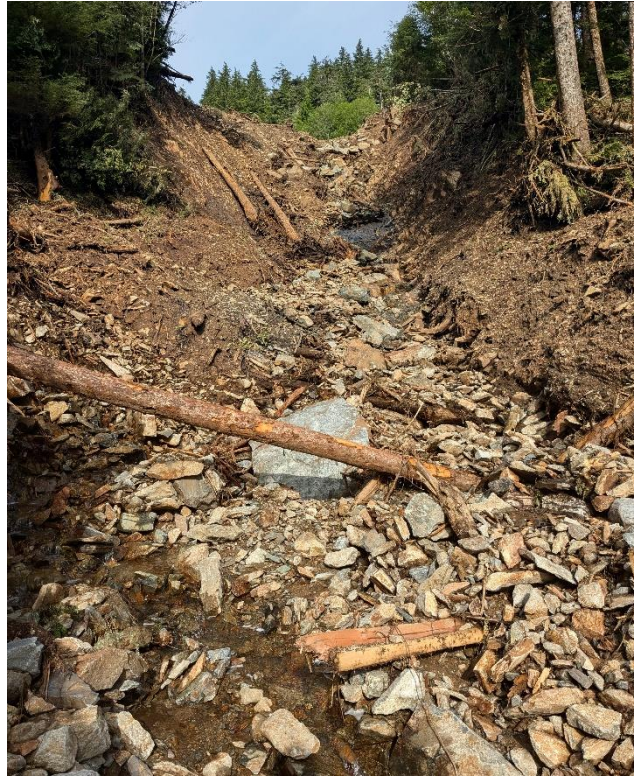
A: Copper Ridge Landslide, Point 1050, Lower Zone, steep slope below access driveway switchback.

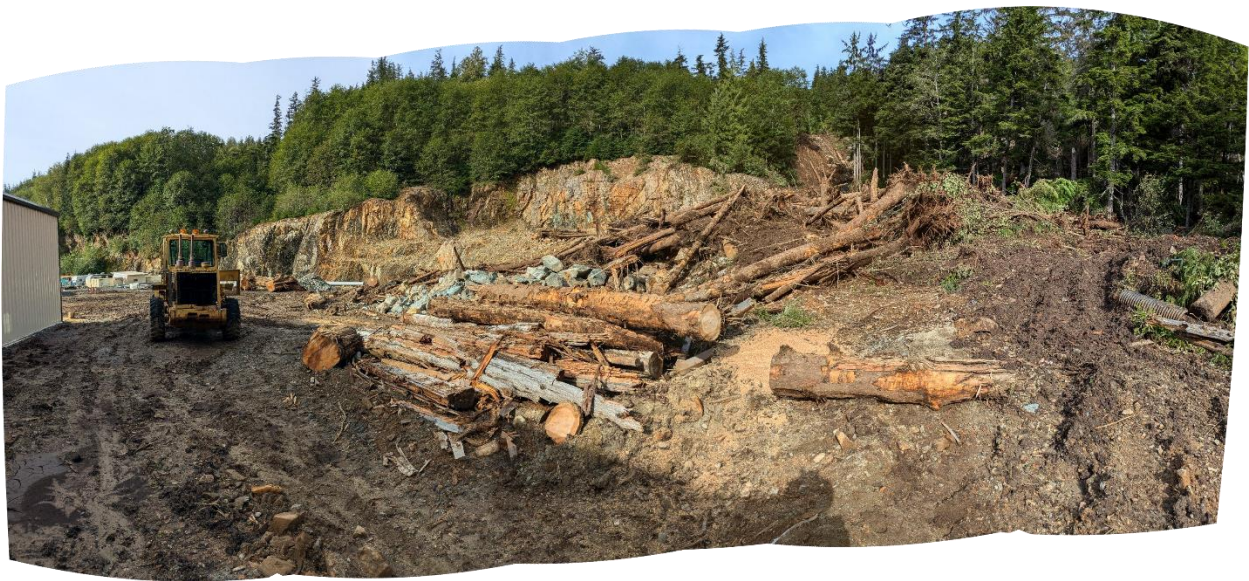
B: Copper Ridge Landslide, Point 1049, Lower Zone, debris accumulation at landslide toe.

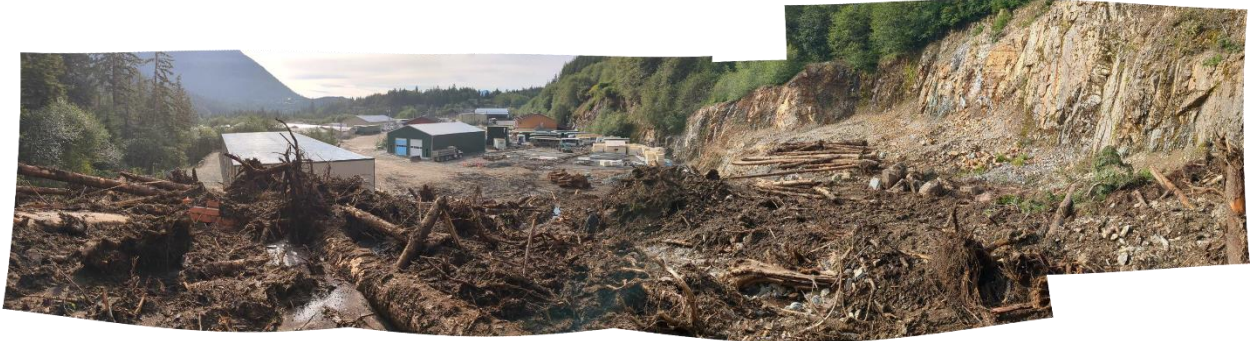
A: Copper Ridge Landslide, Point 1049, Lower Zone, debris accumulation at landslide toe.

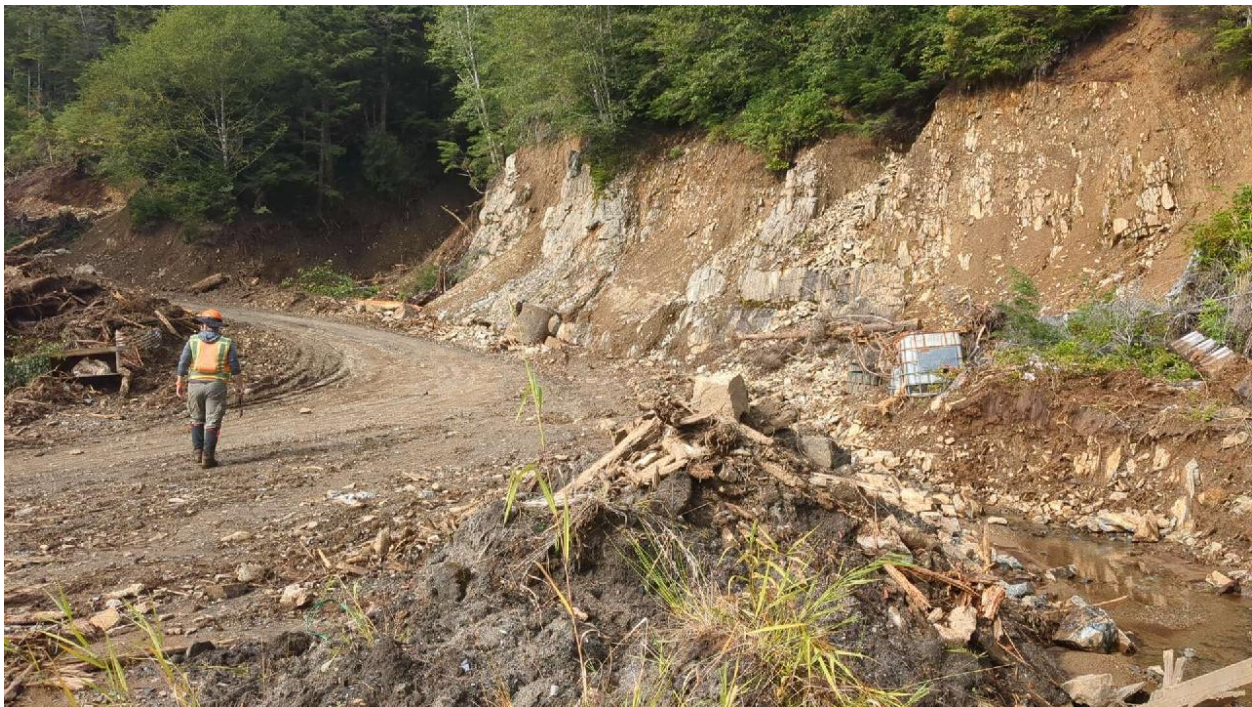
B: Copper Ridge Landslide, Point 1022, Lower Zone, stream channel diversion adjacent to access driveway switchback looking southwest.

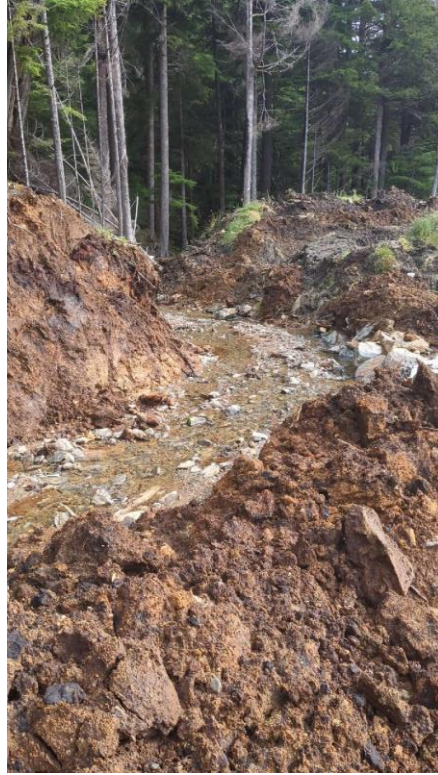
A: Copper Ridge Landslide, Point 1022, Lower Zone, drainage channel diversion adjacent to access driveway switchback looking northeast.

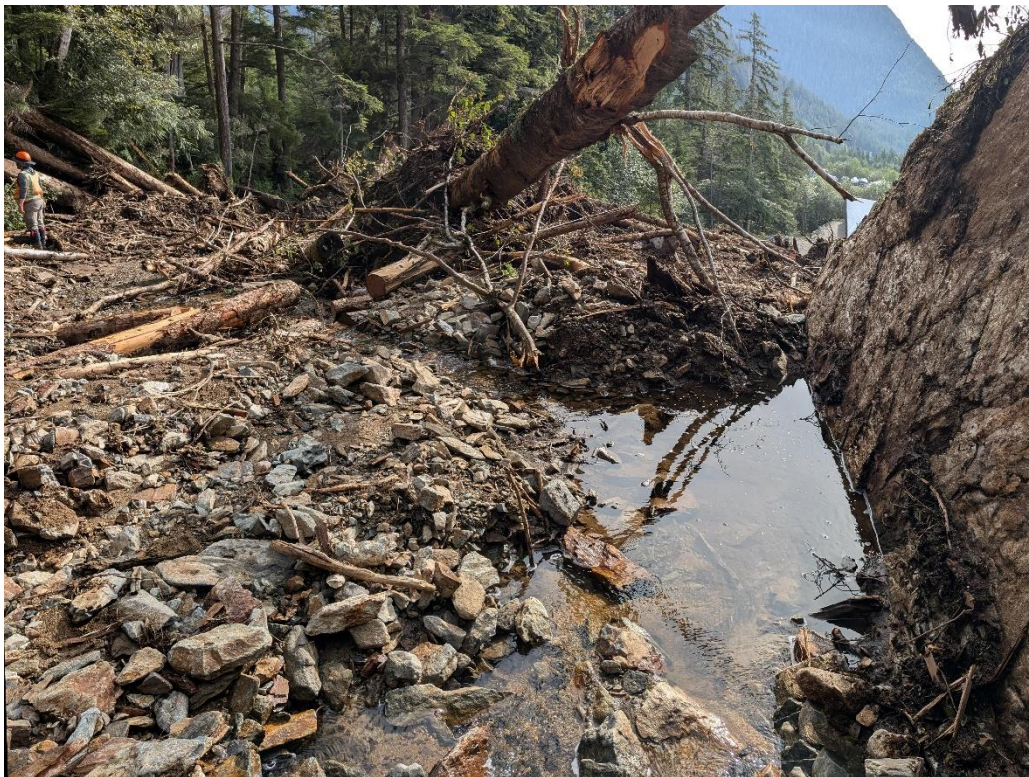
B: Copper Ridge Landslide, Point 1018, Lower Zone, drainage channel diversion at base of steep slope near landslide toe.
