October 1, 2024

3309

**Reconnaissance Observations and Recommendations Report  
3<sup>rd</sup> Avenue and Copper Ridge Landslide Assessments  
Ketchikan, AK**

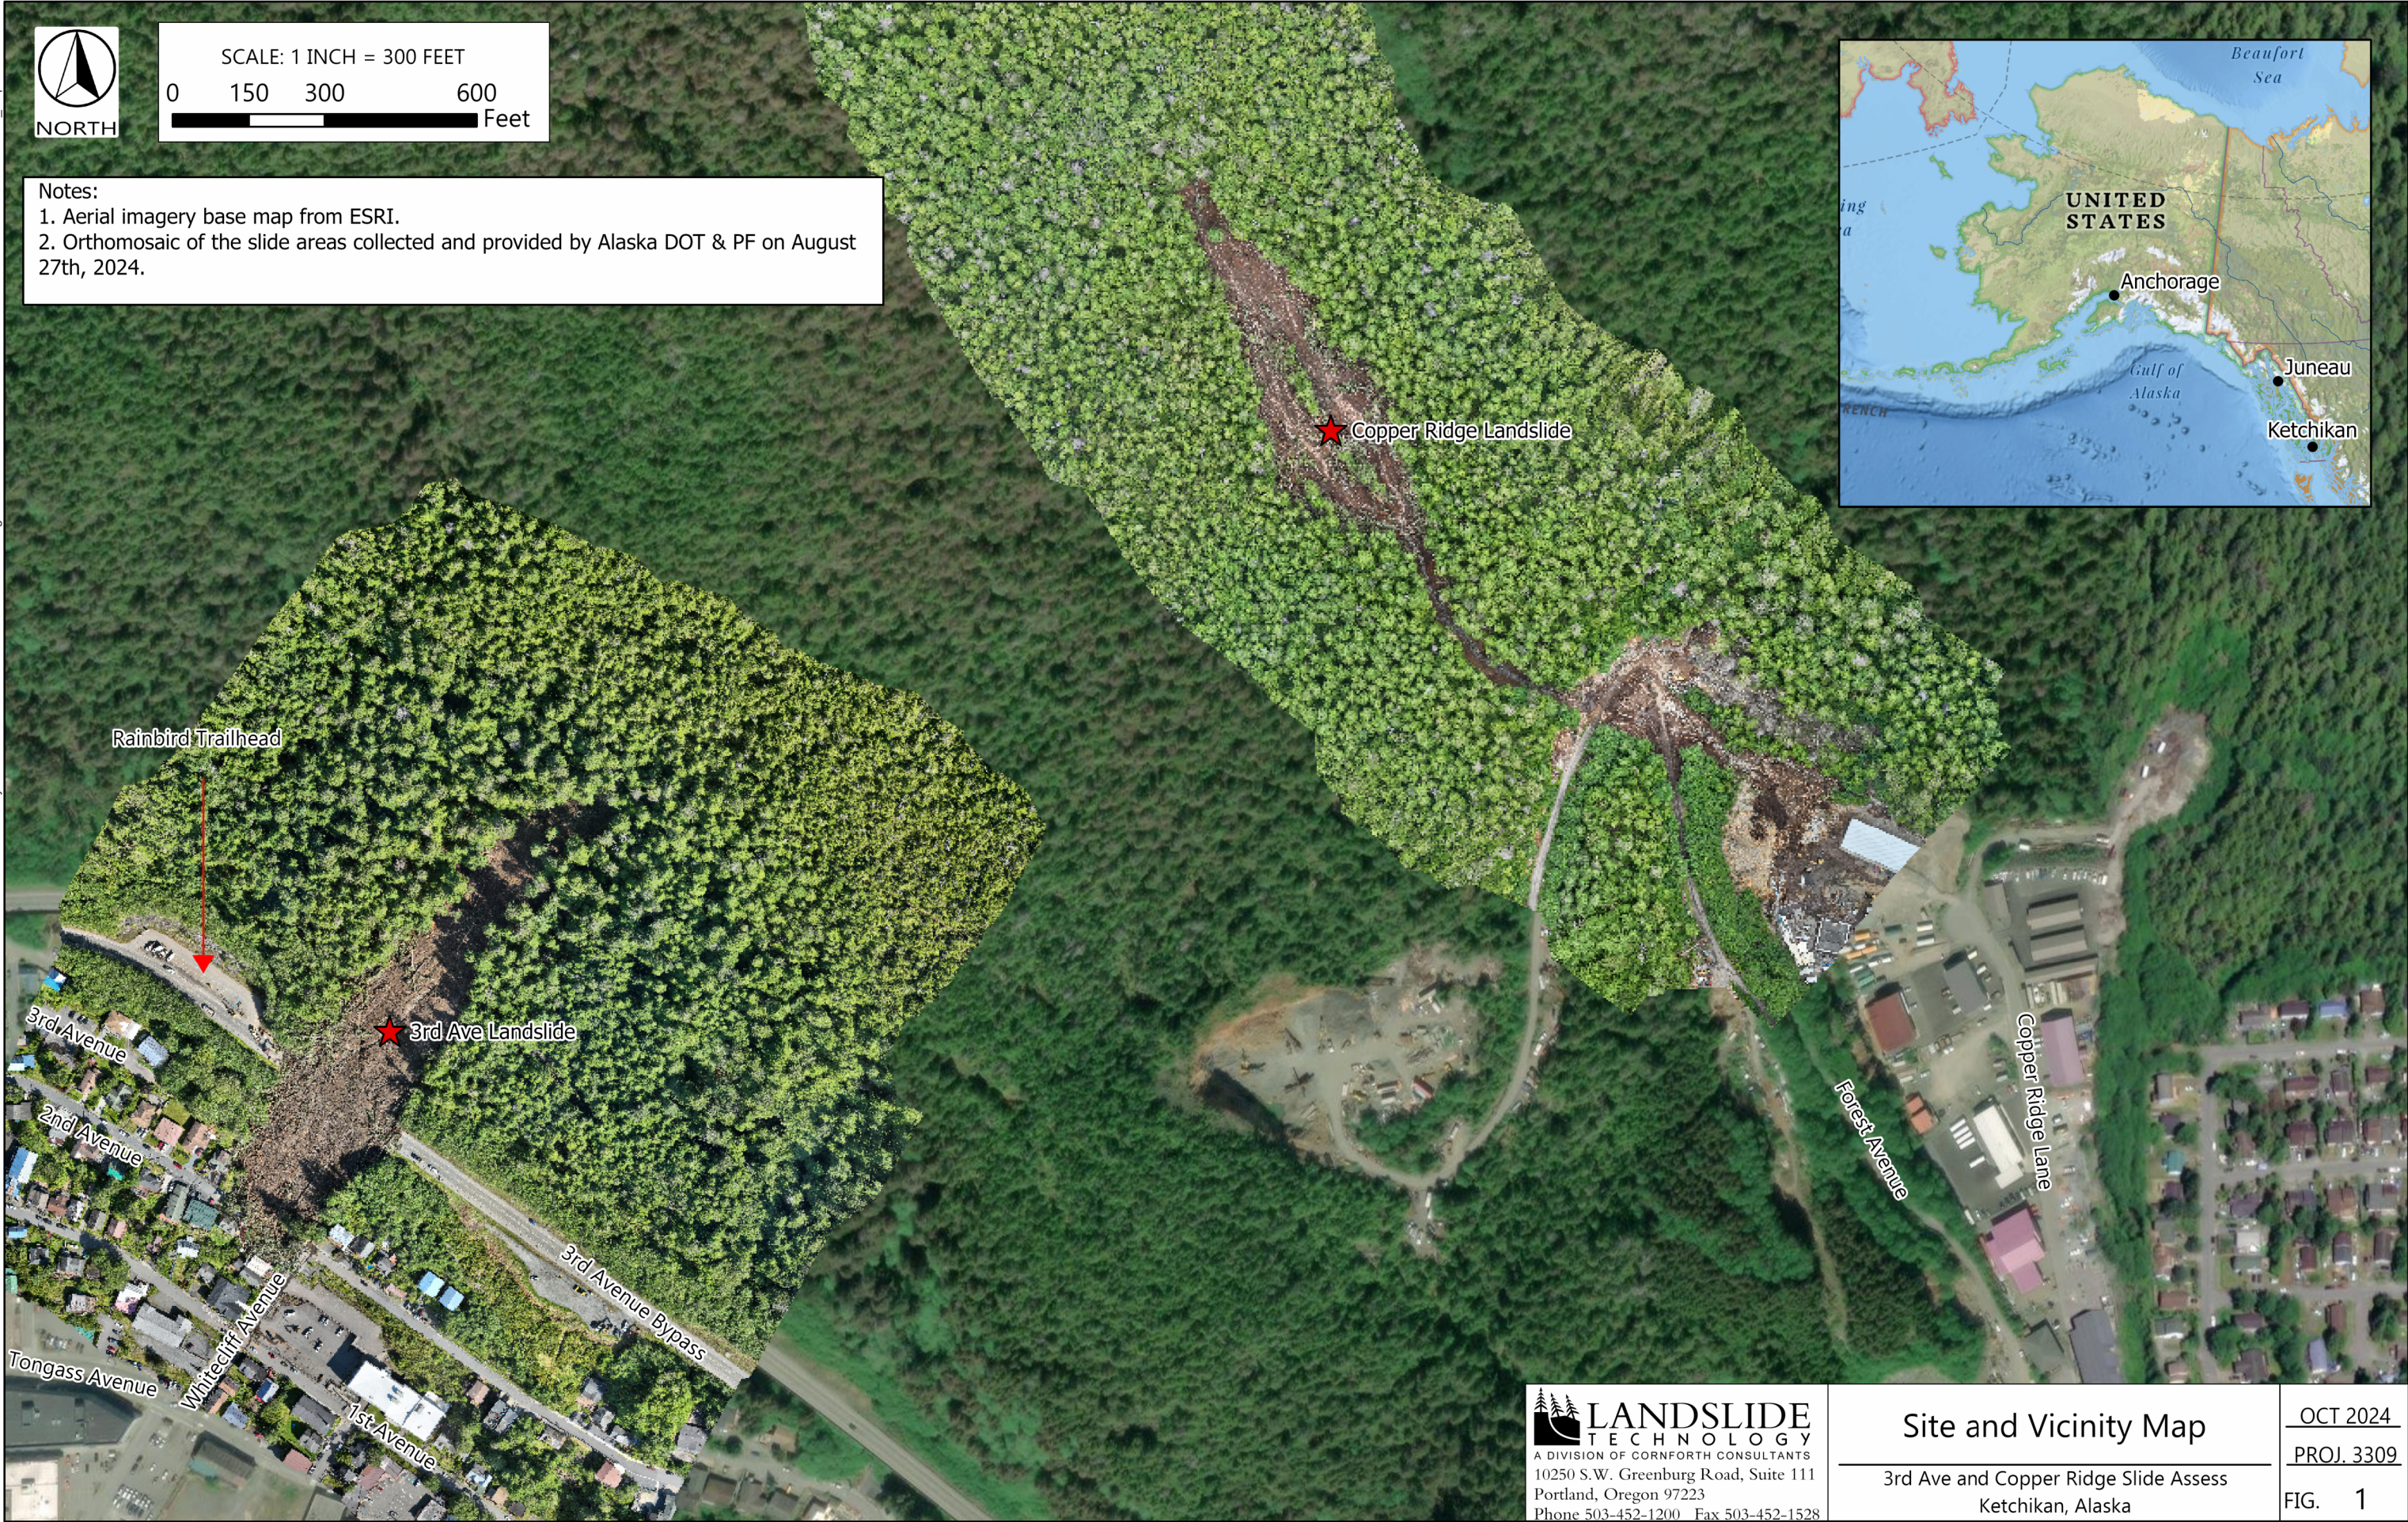
OCT 2024  
PROJ. 3309  
FIG. 1

On August 25, 2024, two landslides occurred in the City of Ketchikan, Alaska (City). One slide occurred above the 3<sup>rd</sup> Avenue Bypass and another on Copper Ridge near Copper Ridge Lane (Figure 1). The 3<sup>rd</sup> Avenue landslide resulted in a fatality, multiple injuries, and property damage. The Copper Ridge landslide resulted in property damage. Following these events an emergency operations center (EOC) was established in cooperation with local fire and police departments, the City, and the Ketchikan Gateway Borough (KGB). As part of the EOC response, the Alaska Department of Transportation & Public Facilities (DOT&PF) and Alaska Department of Geology and Geophysical Survey (DGGs) mobilized to Ketchikan to assist with assessment of slope conditions, monitoring of landslide activity, and evaluation of near-term weather forecasts. Landslide Technology (LT) was contracted by the City to conduct a site reconnaissance to characterize slope conditions within the failure areas and directly adjacent to the slides.

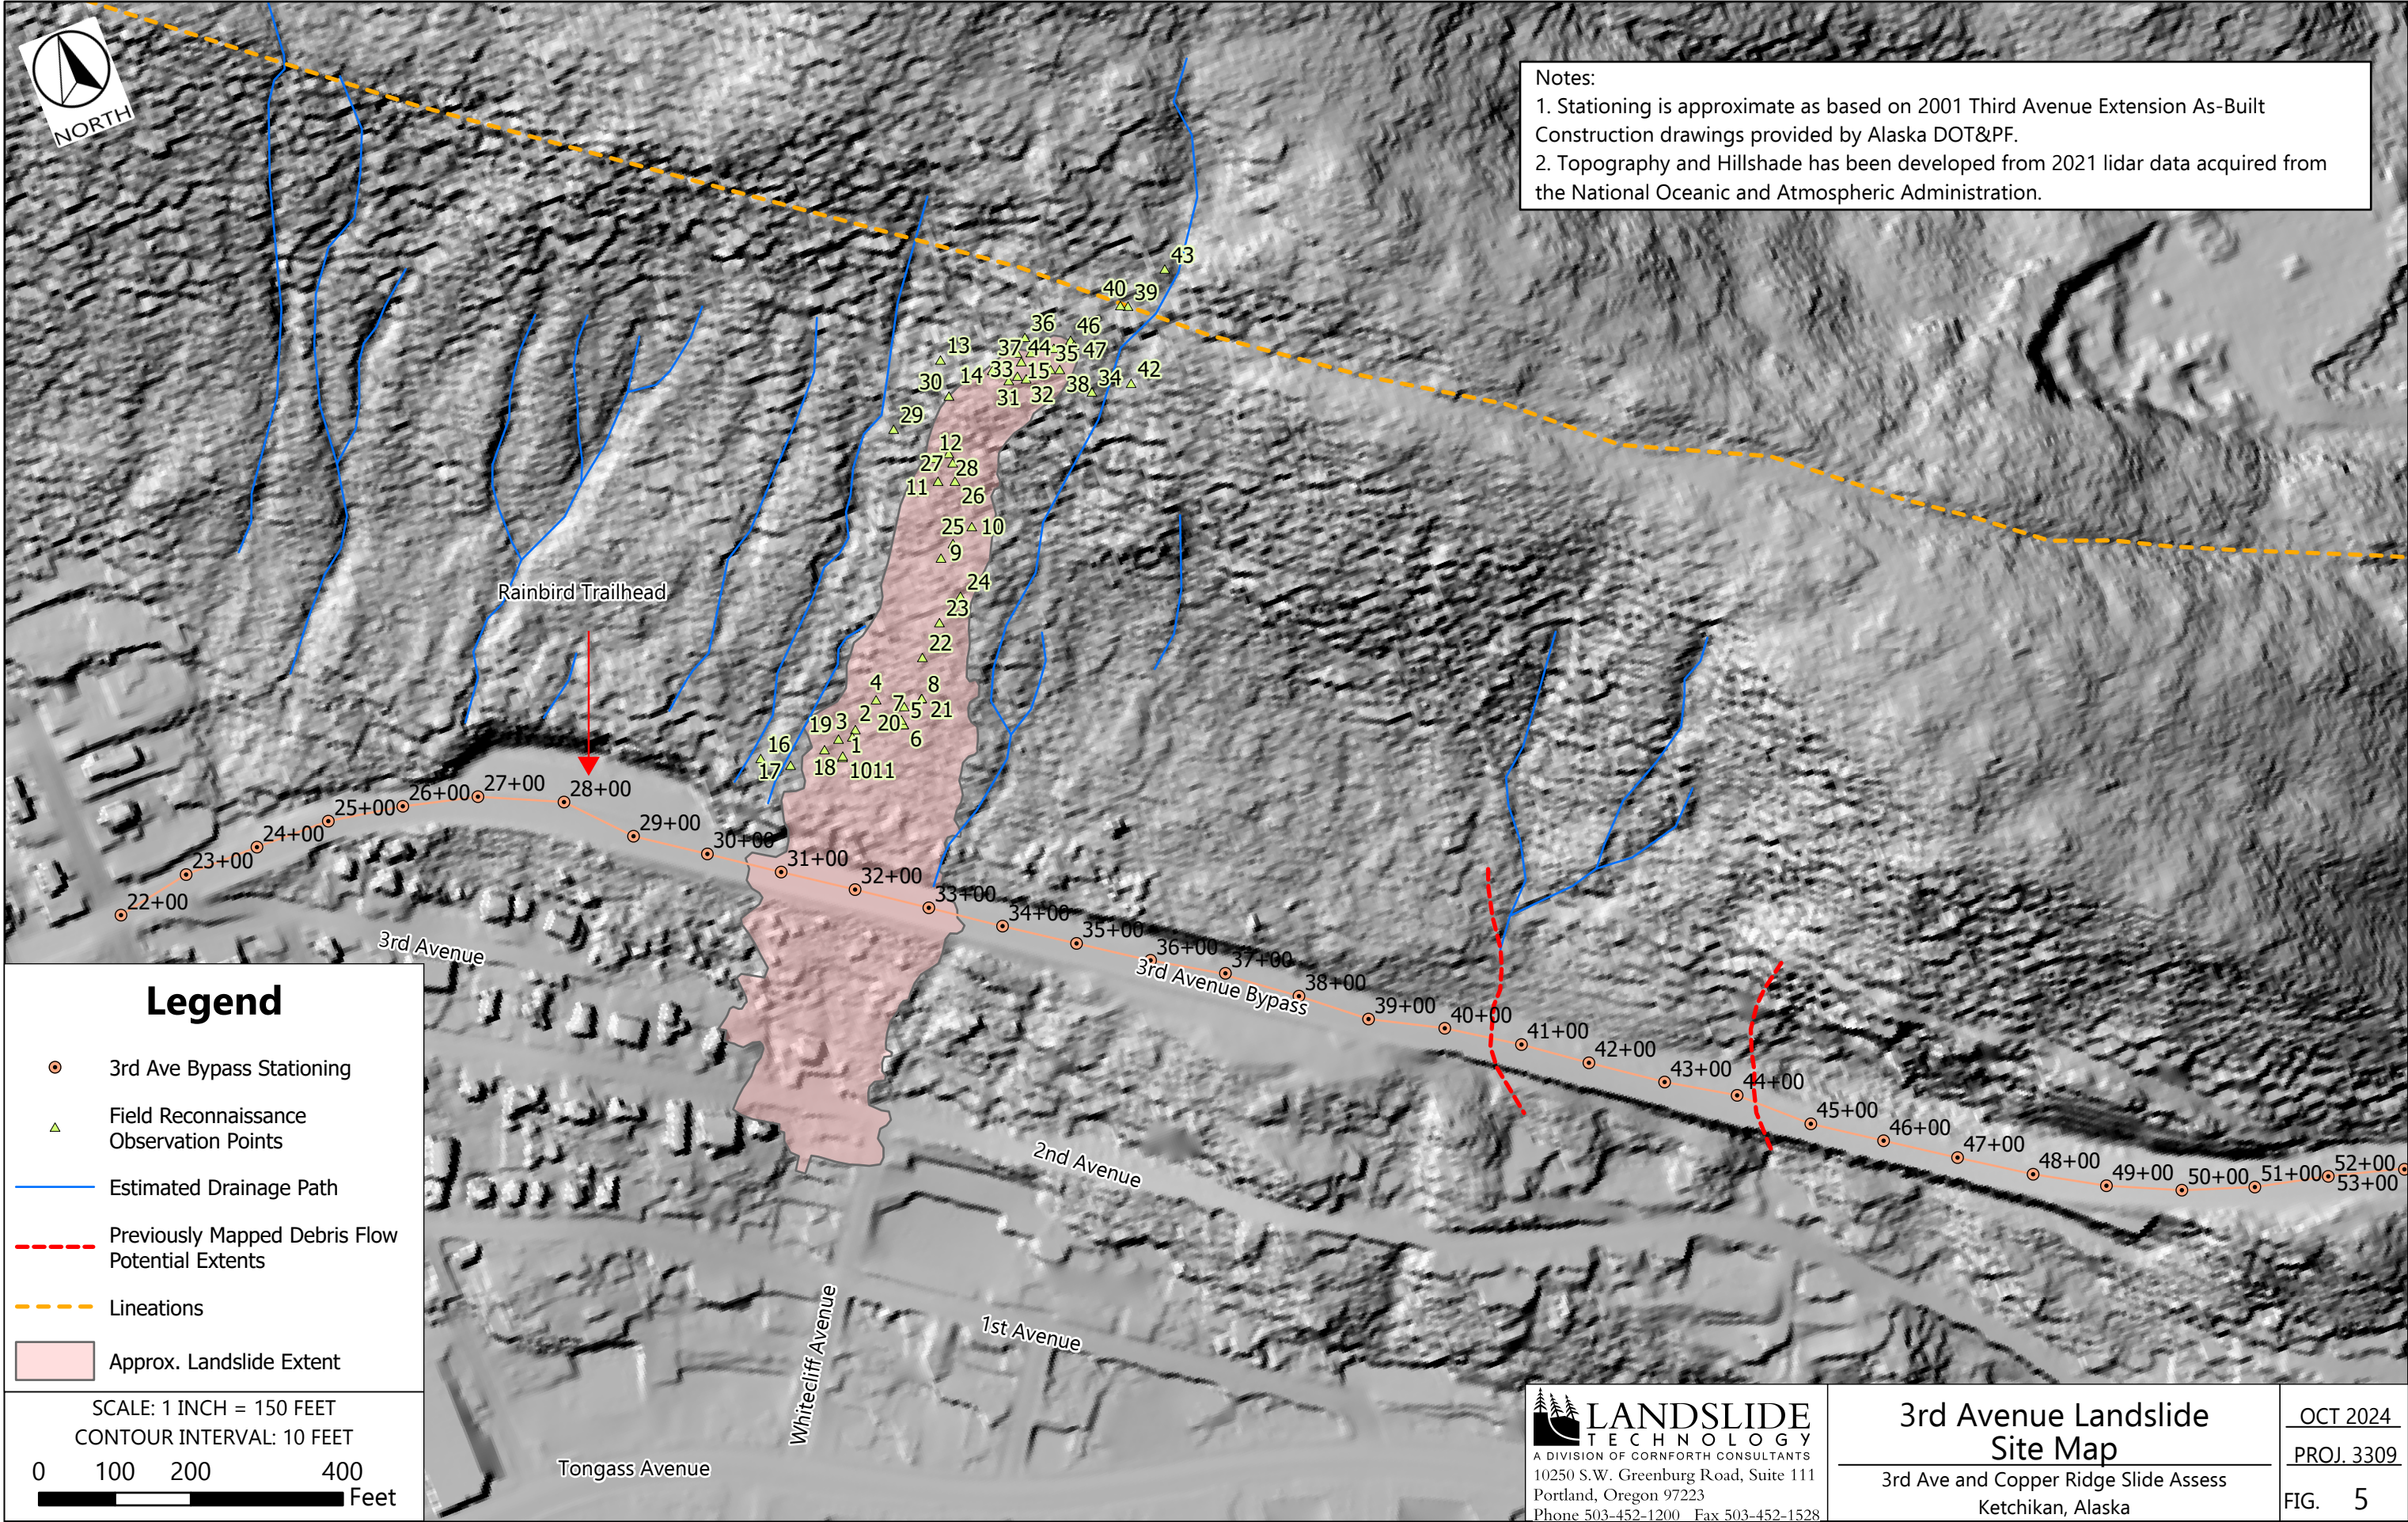
OCT 2024  
 PROJ. 3309  
 FIG. 5

The 3<sup>rd</sup> Avenue landslide occurred between approximate stations 30+50 and 33+30 (Figure 4 and Figure 5). The residential homes impacted by the landslide were situated downslope of 3<sup>rd</sup> Avenue at the toe of a 25° slope. City property was also impacted on 2<sup>nd</sup> Avenue, 3<sup>rd</sup> Avenue, and the 3<sup>rd</sup> Avenue Bypass. The vertical change in elevation from the landslide toe to the top of the landslide (i.e., headscarp) is approximately 560 feet, with the toe located at approximate elevation 80 feet and the headscarp at approximate elevation 640 feet. Prior to the slide event, the slope was densely vegetated

Four geologic materials were observed at the 3<sup>rd</sup> Avenue landslide, including organic overburden, colluvium, glacial till, and phyllite bedrock. These deposits have variable character across the site. Observation locations correlating to the photo exhibits are illustrated on Figure 4 and Figure 5.

Erosion channels observed within the landslide failure area have scoured through the remaining colluvium (i.e., slide debris) exposing glacial till and in some instances phyllite bedrock. Based on interpretations of 2021 lidar data acquired from the NOAA, distinct drainage paths were not present in the landslide area prior to the recent slope movement. It appears drainage within the slide area was more diffuse as opposed to concentrated into a distinct path(s). In contrast, two distinct established drainages are observable to the west and east of the slide area (Figure 4 and Figure 5, Photo Exhibit 10 and 12A).

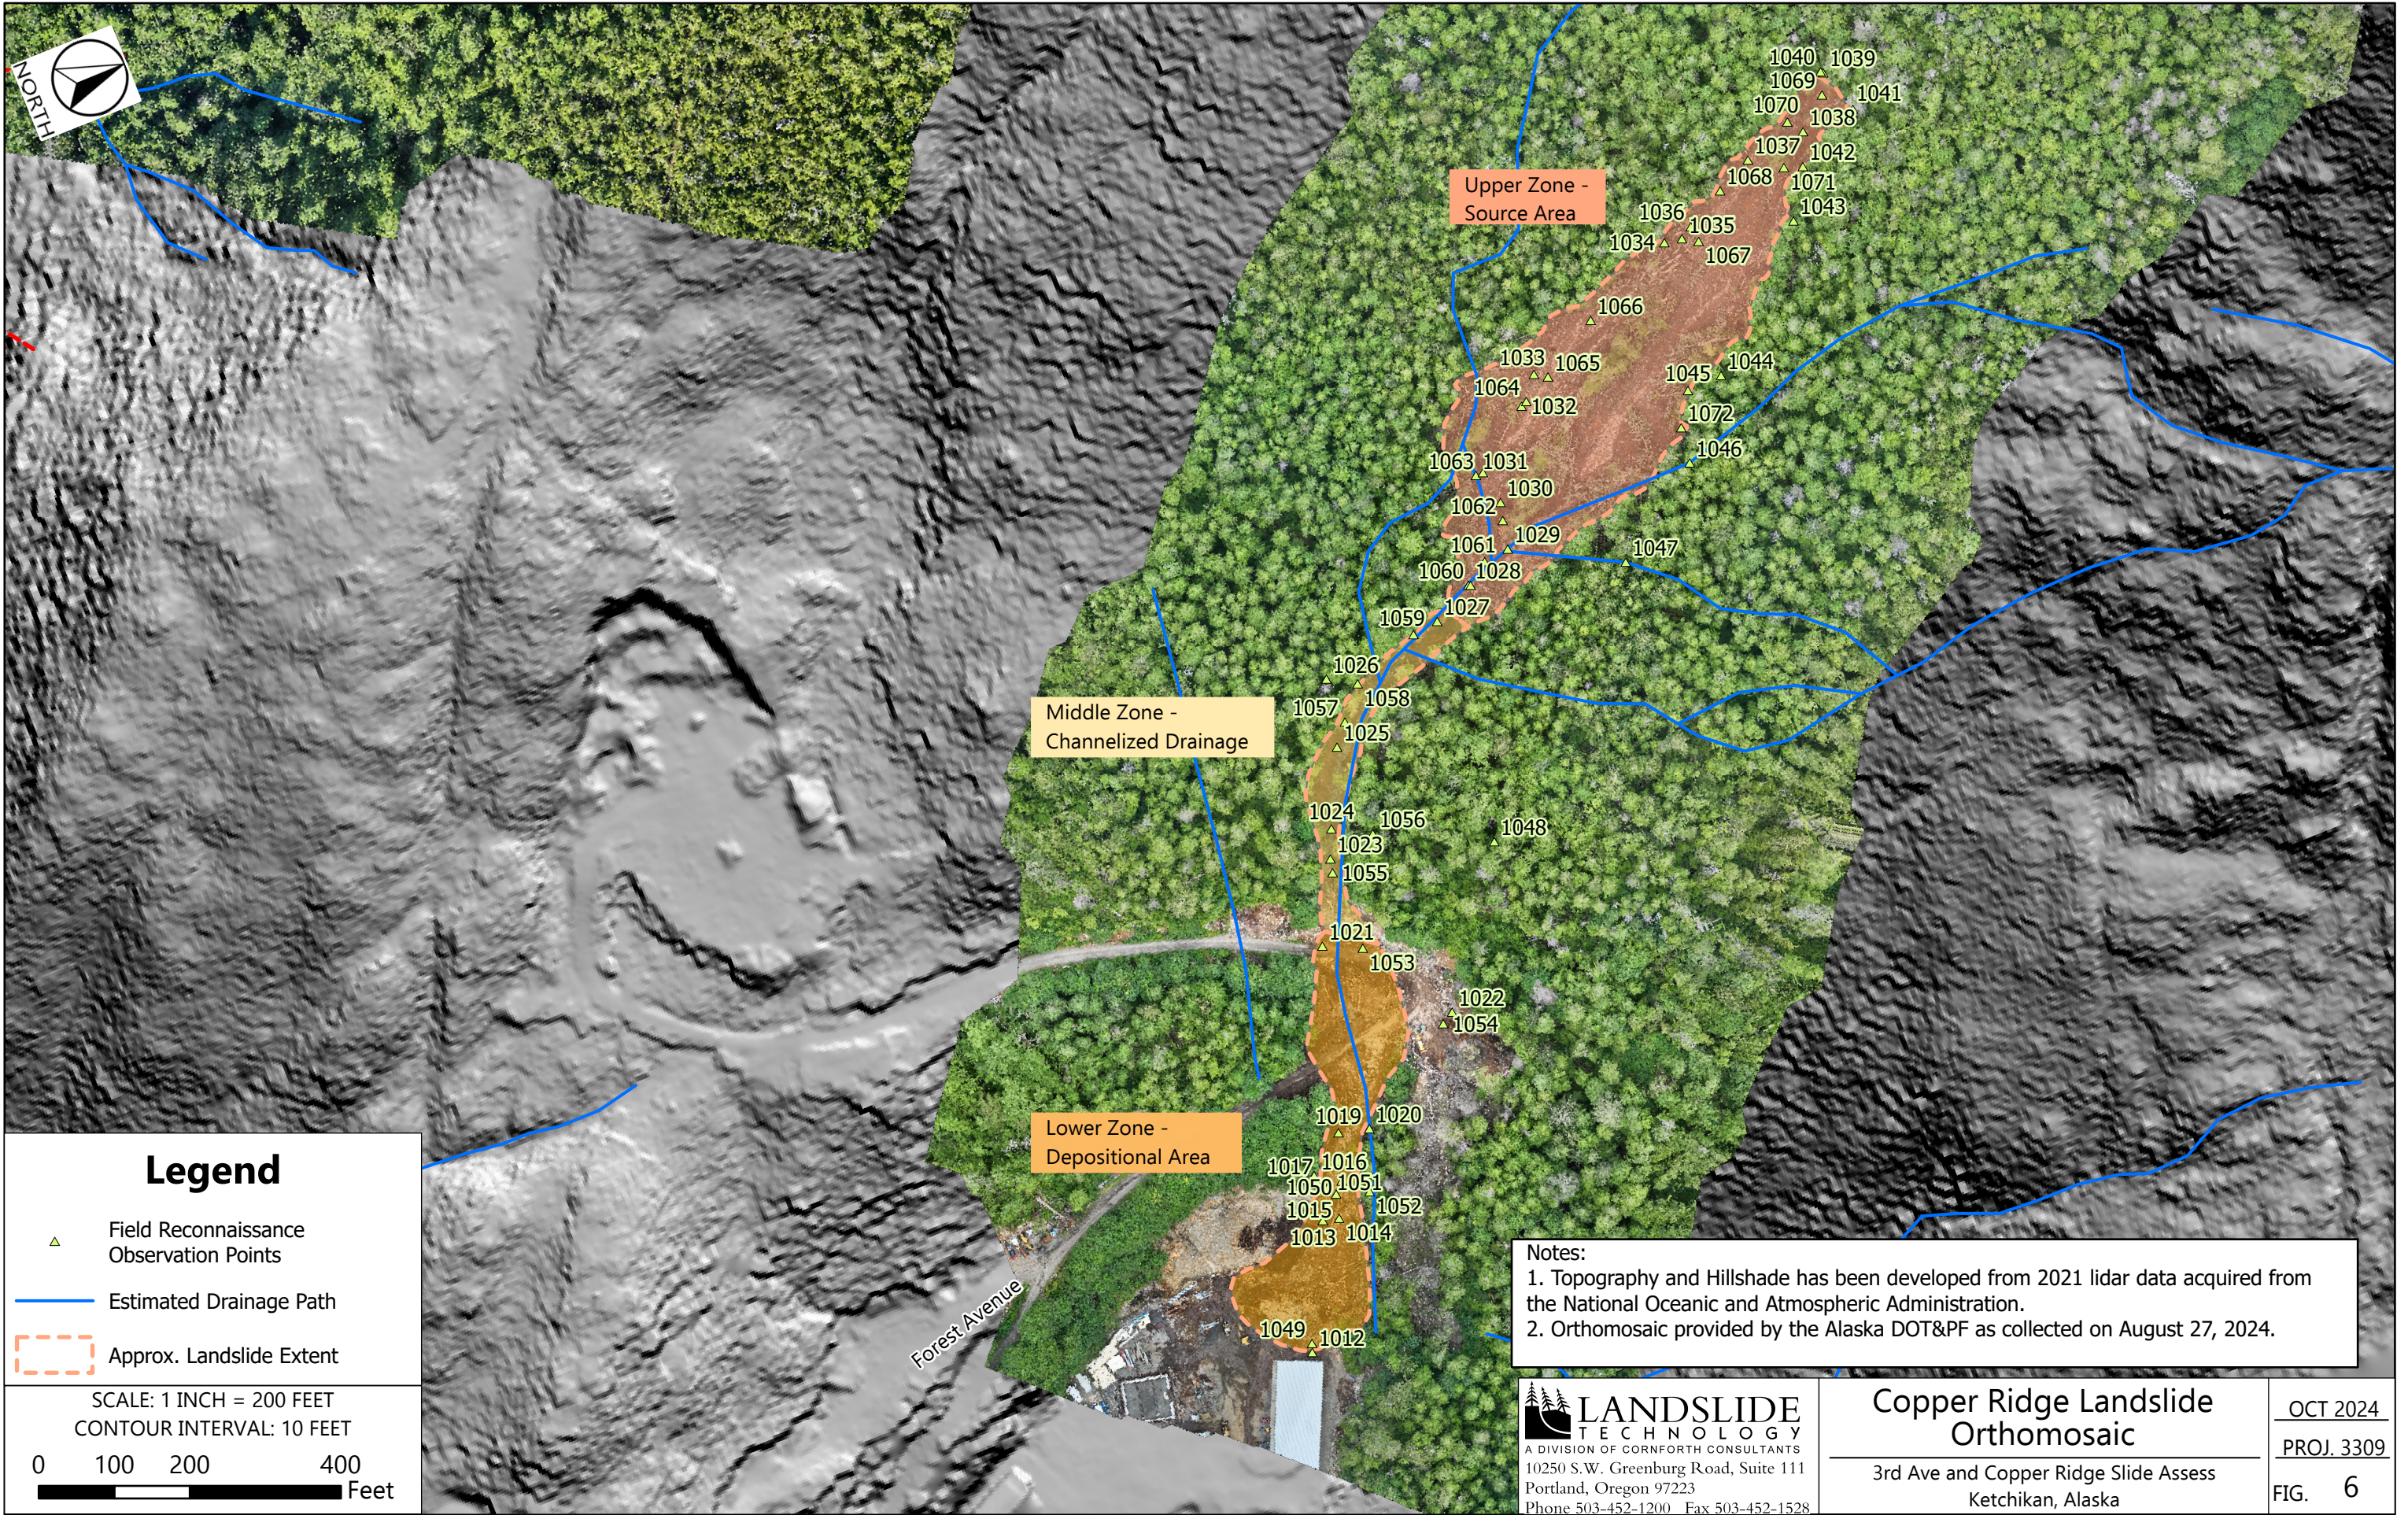
OCT 2024  
 PROJ. 3309  
 FIG. 6

The Copper Ridge Landslide impacted several properties including privately owned lots adjacent to property owned by the City and United States Forest Service (USFS). The slide area is shown on Figure 6 and Figure 7. The slide appears to have initiated on USFS land, moved across KGB property, then private property with an access driveway, next through City property, and deposited debris on private property. The vertical elevation change from the landslide toe to the headscarp is approximately 870 feet, with the toe located at approximate elevation 250 feet and the headscarp at approximate elevation 1,120 feet. Slopes in the slide area ranged from 15° near the toe to 36° near the headscarp as based on pre-slide topography.

Based on field observations and our understanding of the underlying geology, we divided the Copper Ridge Landslide site into three zones; upper, middle, and lower, which have unique geomorphic features<sup>6</sup> (Figure 6 and Figure 7).
